Date of mailing Report *11th July* 18*97* When handed in at Local Office *18* Port of *Antwerp*
No. in Reg. Book. *111* Survey held at *Antwerp* Date, First Survey *30th June* Last Survey *1st July* 18*97*
(No. of Vials) *7*

95 on the ~~Wood, Iron or Steel~~ *Iron*, *Malabar* Master *T. Appled*
 TONNAGE:— Built at *Pennacott* By whom *Tobacco's Co* When *1843* *6th*
 GROSS *28th 46* Owners *De Anon. Belge Americaine* Port belonging to *Antwerp*

REPAIRS, OR EXAMINATION AS PER RULE, FOR *Second Special Survey N.3, Damage repairs*
Special Survey N.3 as prescribed in the Rules (please see my Report N.3362) none

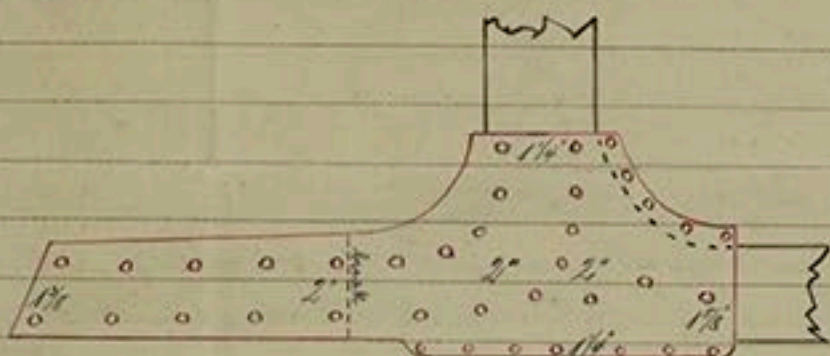
The shell, plating, armchairs, and left ascertained and found as shown in
Sketch on the other side.

Thickness of shell plating under sidelite ascertained and found as given in sketches.

Reduction allowed at
ends for present Rule.

Original thickness
1.09 Gm. Kiesel
