# LLOYD'S REGISTER OF SHIPPING

G.T.V. "AURIS"

In connection with the machinery of the above vessel, on which the survey report is now being forwarded, we think it well to advise you of the following points for record purposes.

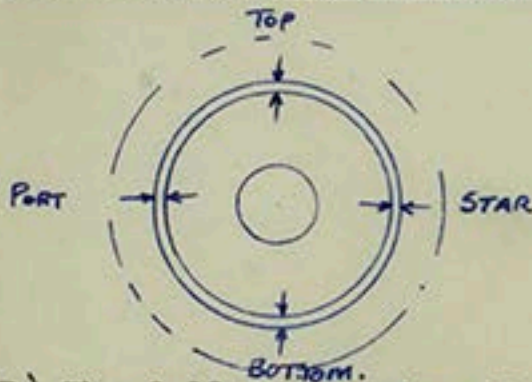
Clearances (cold) at Stage 5.

(6) H.P. turbine No. 1, i.e. the working turbine during the Engine builder's basin and sea trials, was removed and replaced by the spare H.P. turbine No. 2, just prior to the vessel being taken over by the Owners. The No. 1 turbine was examined as far as possible through the inlet and outlet branches and sighting openings and found in good order.

Blade tip clearances which had been recorded before lifting the turbine, show a permanent decrease against the original readings as follows :

Pos.	Port	Top	Star	Bottom
Present				
Clearance	.054	.072	.066	.072
Original	.074	.83	.072	.080
