S. S. Dominica ex Digby

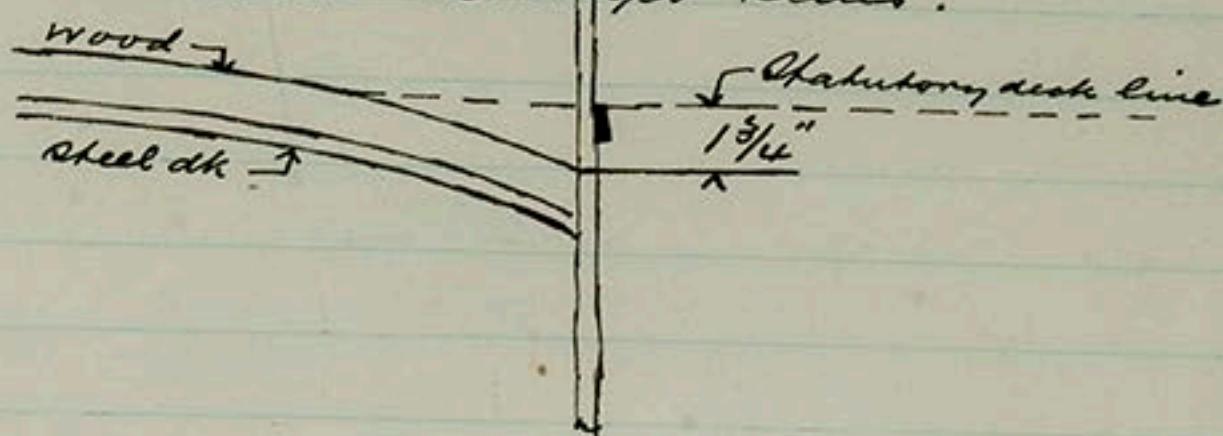
This submitted the Dublin surveyor be informed that his remarks have been noted, but it would appear from his letter that the vessel will be running with more freeboard than that assigned, and not with less freeboard. This is partly due to an error in his method of setting off the statutory deck line, and partly due to the error regarding the wood deck. He should be informed <sup>for guidance</sup> that the statutory deck line should be set off as indicated in the following sketch, i.e. - from the point where the wood deck intersects the ship's sides.

The owners should be informed that an error has been made in marking the freeboards and it would appear that all the marks are  $1\frac{3}{8}$  " too low. <sup>& the vessel would consequently load deeper by this amount</sup> They should therefore state when and where the marking can be corrected and verified in order that the necessary instructions may be issued to the Society's Surveyors.
