WELDED JOINTS IN SHIP CONSTRUCTION.

THE "FULLAGAR" AFTER ELEVEN YEARS' SERVICE.

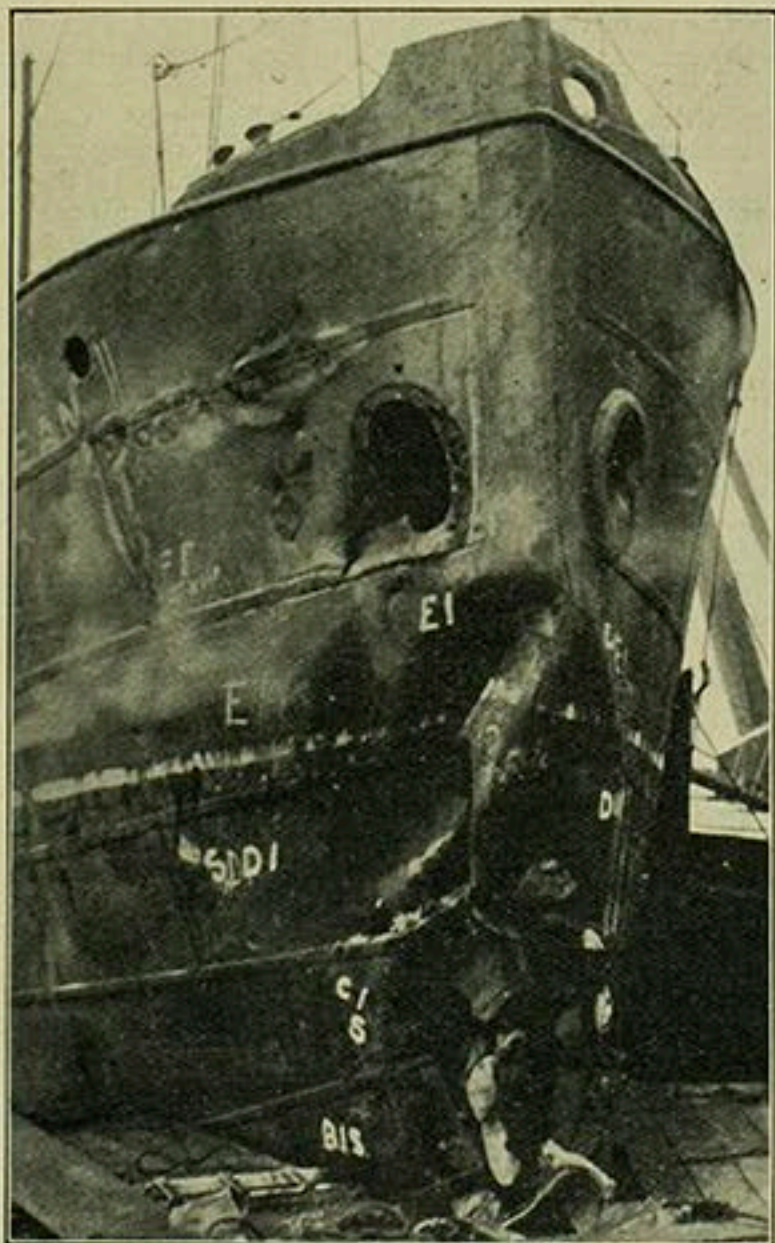
The *Shean* struck a rock cliff in the Saanich Inlet, near Victoria, when going at full speed, and had 10,000 bags of cement on board. The photographs show the extent of the damage, and on examination, it was found that in no case did the plates tear apart at the welds, but above and below in the solid plate. Lloyd's and the underwriter's surveyors have stated that the relatively slight amount of damage was a remarkable tribute to the welded vessel.

Had the vessel been riveted, the damage would have no doubt extended beyond the fore peak bulkhead and caused flooding of the cargo space, in which case the cargo would have been irretrievably ruined, whereas less than 400 sacks were damaged, also the vessel would have probably sunk, as she had about 16 ft. of water under her amidships and further aft. The vessel has since been repaired in strict accordance with her class, has passed her tenth annual survey satisfactorily, and is in good condition.

Fig. 2. — Renamed "Caria" and "Shean," the "Fullagar" met with an accident in the Saanich Inlet, near Victoria. At the time she had 10,000 bags of cement on board and was travelling at full speed.

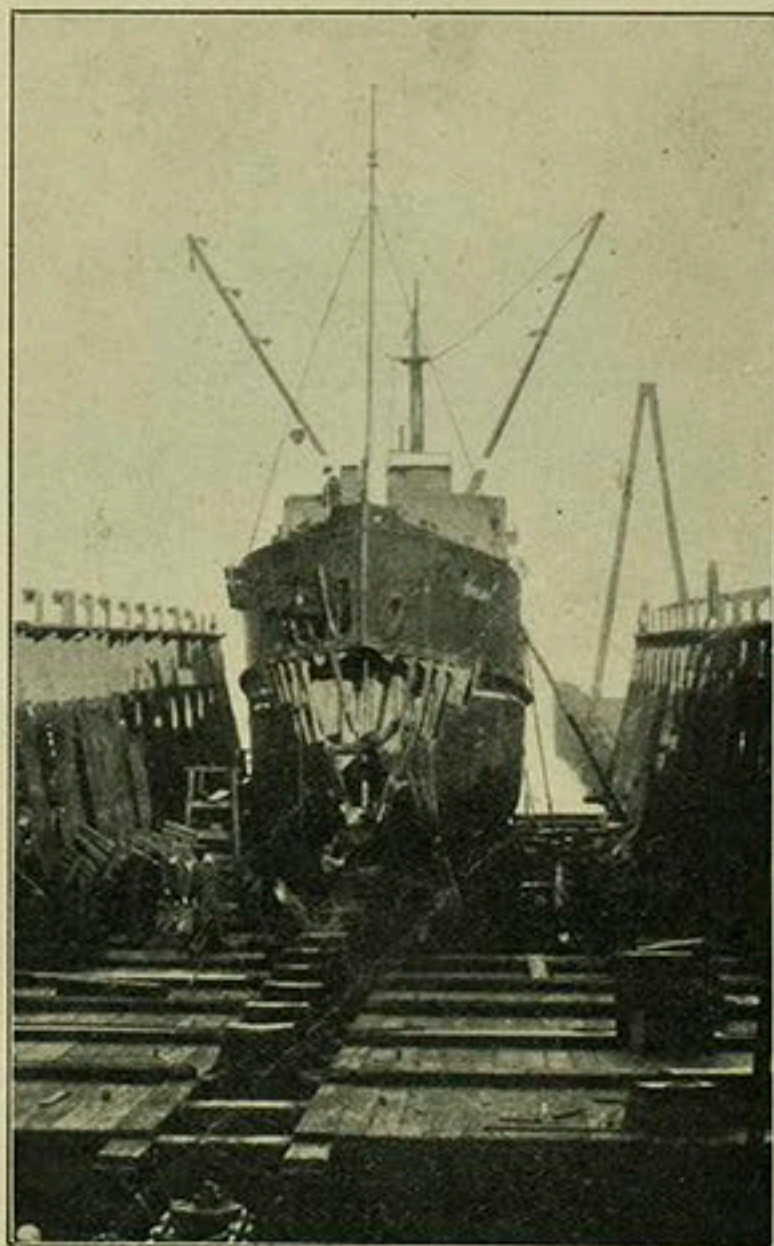
Fig. 3.—Both this illustration and Fig. 2 show the extent of the damage she sustained. Upon examination it was found that in no case did her plates tear apart at the welds, but above and below in the solid plate.
