# Lloyd's Register of Shipping.

OF MELBOURNE,

30th December, 1940.

Melbourne Report N° 7667  
dated. 2-1-41.  
20/12/1940.

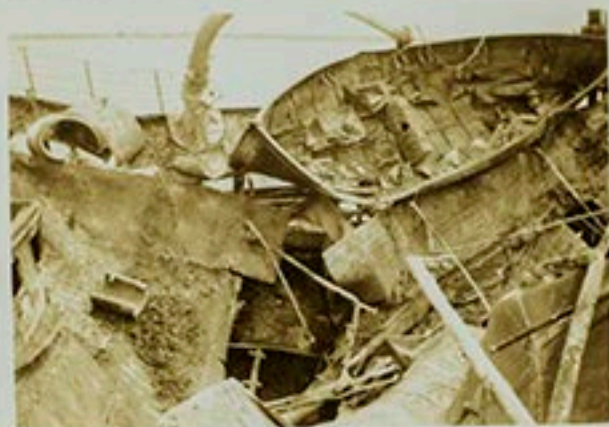
Bunker space. The bunker hold was flooded and not accessible. The 'tween deck steel work was generally distorted through overheating.

Forward of Bunker Hatchway.

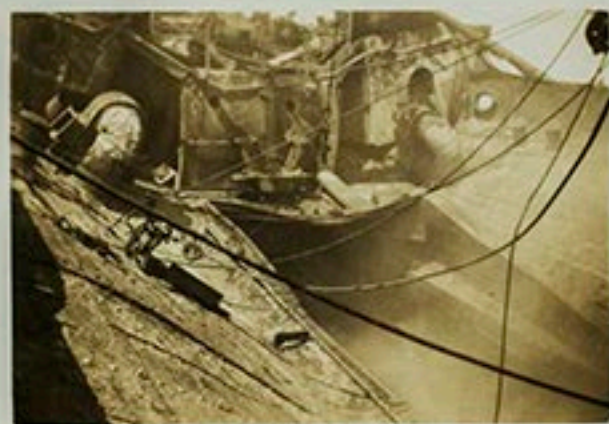
No. 3. Not accessible for examination. The upper deck in way of all holds had collapsed, the hatchway coamings at Nos. 1 & 4 hatches

hatches being practically at level of 'tween deck coamings. The fire was still smouldering in Nos. 1 & 2 holds.

The Upper Deck at No.1 Hatchway.

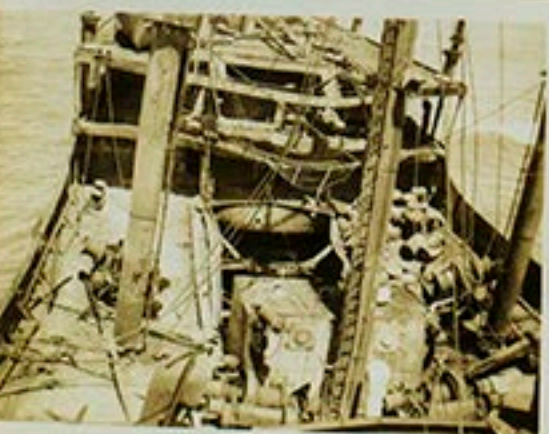
The Upper Deck at No.4 Hatchway and Poop.
