# Lloyd's Register of Shipping.

Ship's Name BALMARINO.

Official No. 108628.

Memorandum of alterations reported since ship was surveyed for assignment of Load Lines in .....

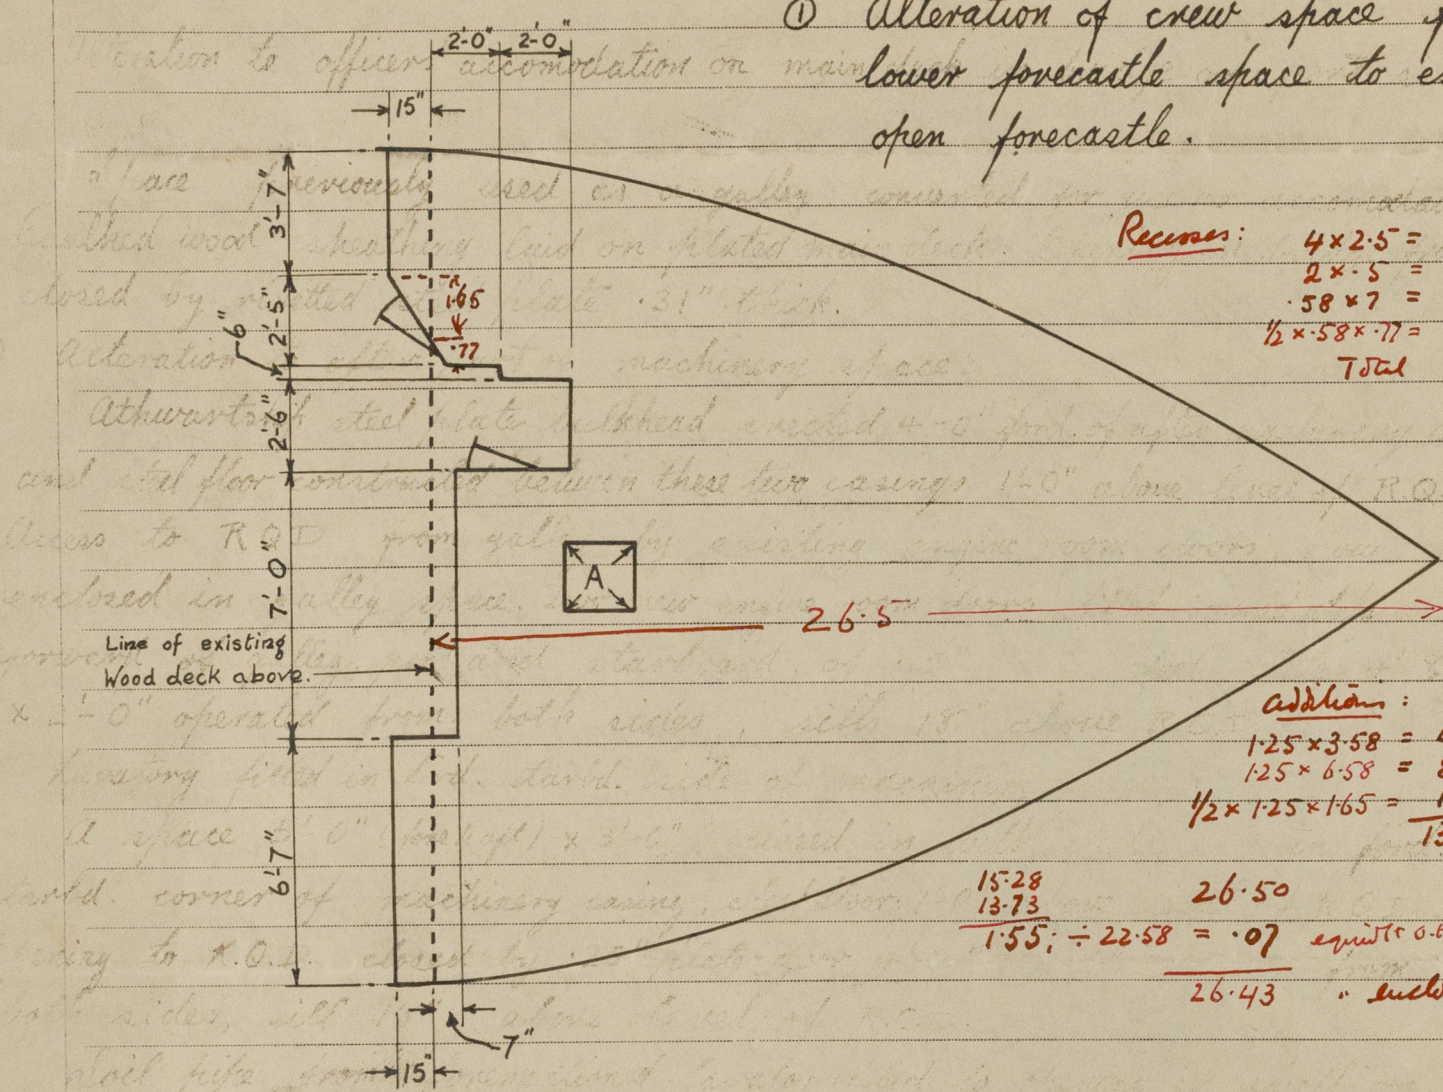
① Alteration of crew space from lower forecastle space to existing open forecastle.

Steel bulkhead erected across existing open forecastle (see above sketch) coaming and plating 25", stiffeners 2½" x 2½" x 26" spaced 30" apart, openings 4'-4" x 2'-0" closed by steel door operated from both sides, one at 4'-3" x 2'-0" closed by solid wood door 1½" thick operated from both sides, height of sills 18", height of casing 7'-0".
