Lloyd's Register of British & Foreign Shipping. 12022
SURVEYS FOR FREEBOARD. 22802

Port of Survey Dundonald
Date of Survey 29th May 1906
Name of Surveyor J. Allan

Ship's Name.	Gross Tonnage.	Official Number.	Type of Ship.	Date of Build.	Particulars of Classification.
<u>Sunhild</u>	<u>1559</u>	<u>2269</u>	<u>Well</u> <u>SK</u>	<u>1896</u> <u>11 mo</u>	<u>+100 A1</u>
Number in Register Book	<u>766</u>

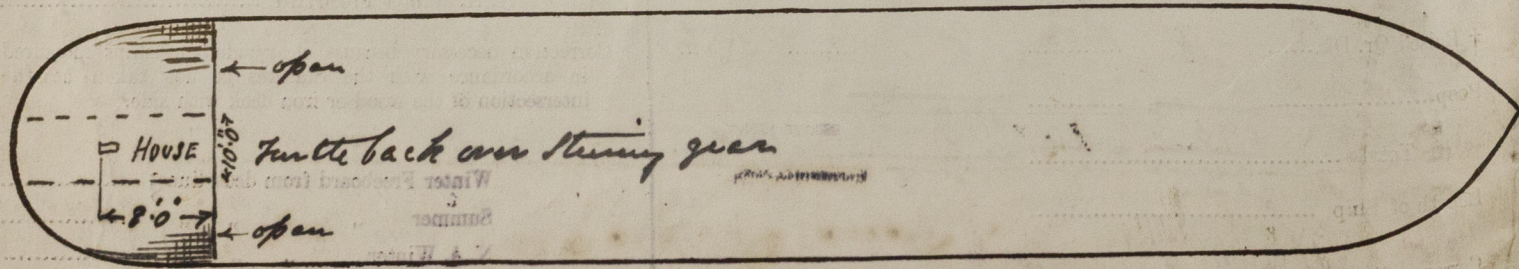
Show hereon the actual measurements of sheer, draft, erections, breaks in line of floors, &c.

Describe how and to what extent it is Stiffened, give scantlings and spacing of Angle Irons, Bulb Plates, etc. *Angles 4 1/2 x 3 x 8/16 spaced 30" apart braced at bottom.*

* *As the ~~water~~ of the bridge front is lined on the inside it was impossible to accurately see the whole of the plating it appears however to be stiffened as per accompanying sketch received from the owners representative.*
