# REPORT of SURVEY for REPAIRS, &c.

Date of writing report 31-3-1947 When handed in at Local Office 31-3-1947 Port of BOMBAY  
 Survey held at BOMBAY Date, First Survey 8-11-46 Last Survey 10-3-1947  
 No. in Reg. Book 77018 on the Woolly Iron or Steel Screw Steamer "KILWA" (ex. s.s. "KILUNGCHOW") (No. of Visits 39)

TONNAGE:— Built at Greenock By Whom Scotts' S.B. & E. Co. W. W. W. YEAR 1921 MONTH -  
 GROSS 2653 Owners British India S.N. Co. Ltd. Owners' Address -  
 UNDER DK. 2225 Managers - (If not already recorded in Appendix to Register Book).  
 NET 1545 Port belonging to London.

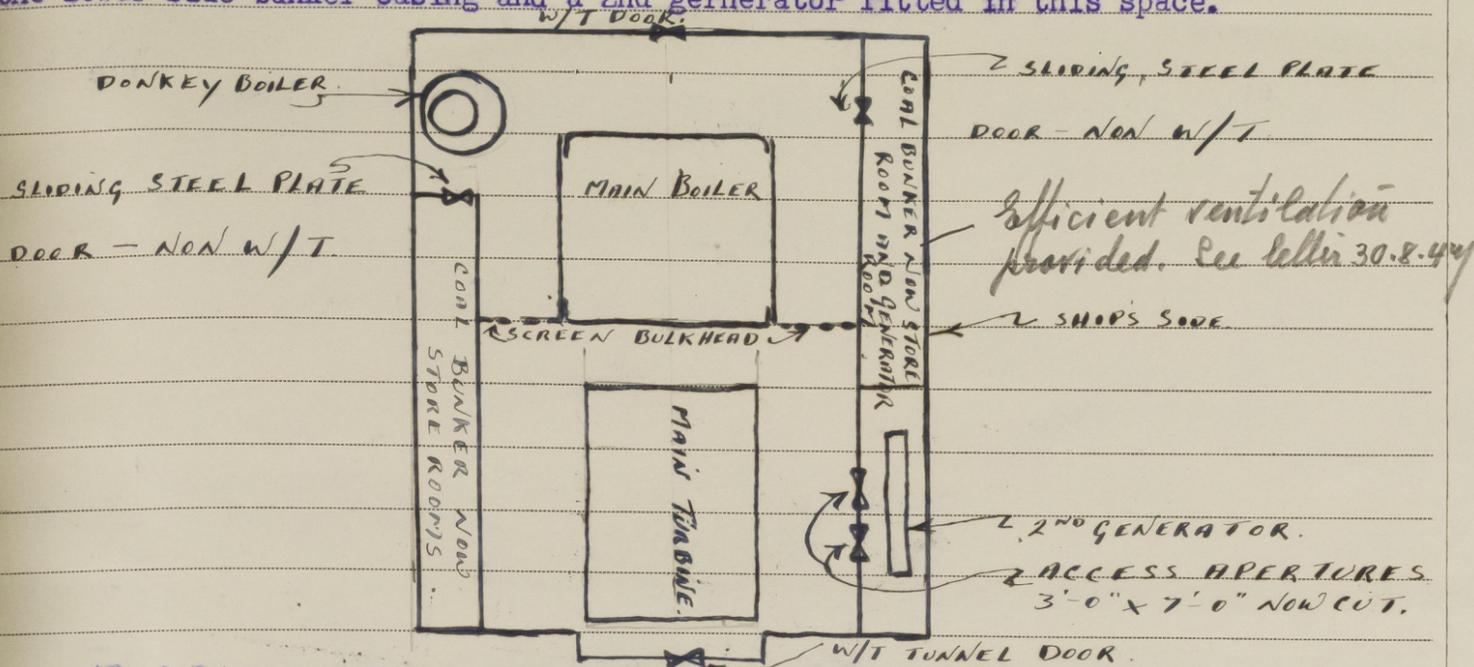
On the Starboard side of the engine room two access apertures have been cut in the lower side bunker casing and a 2nd generator fitted in this space.
