REPORT OF SHIP SURVEYS AND REPAIRS

S.S. "REDBANK" Tons gross 10,643
By Whom Alabama D.D. & S.B. Co. Year 1944 Month
Owner's address (If not already in R.B.)
Port of Registry London
Drydock in drydock Name of Dock No. 3 Falmouth Docks Date of last examn. in Drydock 22/12/58
in existing particulars in the Register Book should be reported and underlined.

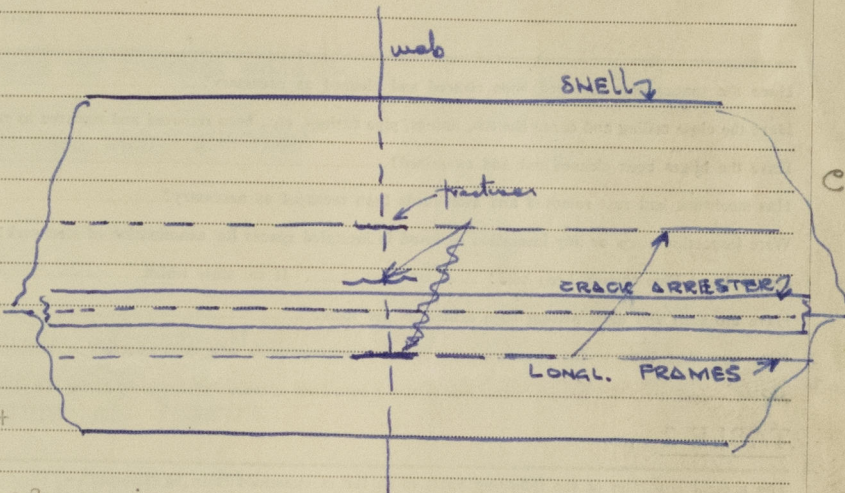
RS - Wear & Tear:- Shell plating
board side, one plate in No.6
carrying side crack arrester,
ured in way of shell web, above
arrester, now part renewed,
length. Shell webs (2) part
wed in No.6 tank both port &
board. Shell plating starboard
locally wasted at top edge of crack
ster below deck scupper in way of No.4
now part renewed 5'0" x 4'0".
