## REPORT OF SHIP SURVEYS AND REPAIRS

No. in R.B. 09270 on the Iron or Steel SS YSS Empire Boice.  
Built at Glasgow By Whom Harland Wolff Ltd. When WRECK 291  
Owners Ministry of Transport Owners' address (If not already in R.B.) SECTION  
Managers Atlantic Steam Nav Co. Ltd. Port of Registry No  
Surveyed Afloat or in Drydock BOTH Name of Dock ELDERSLIE DRYDOCK & ELDERSHE Date of last examn. in Drydock 9/8/57  
DOCKYARD (AFLOAT).  
N.B.—Any alterations to existing particulars in the Register Book should be reported and underlined.  
Last Report: No. 146324 Port LIV  
To be filled in at Head Office.

### EXAMINATION AND REPAIRS AS PER RULE FOR CONDITION.

## "EMPIRE DORIC" (Sheet 2.)

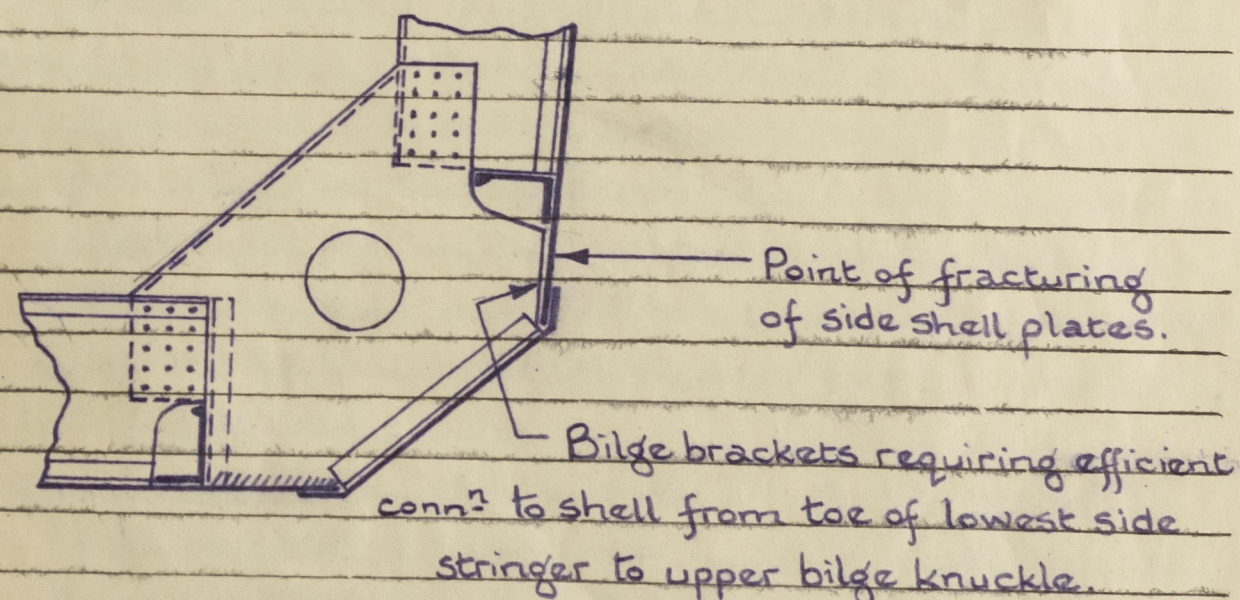
A tendency to fracture was noted in the side shell plates in the strake above the bilge in way of the side transverse webs amidships (p. & s). Internal examination revealed that the bilge bracket portions of the web frames required to be efficiently connected to the shell in way. (See sketch below.)

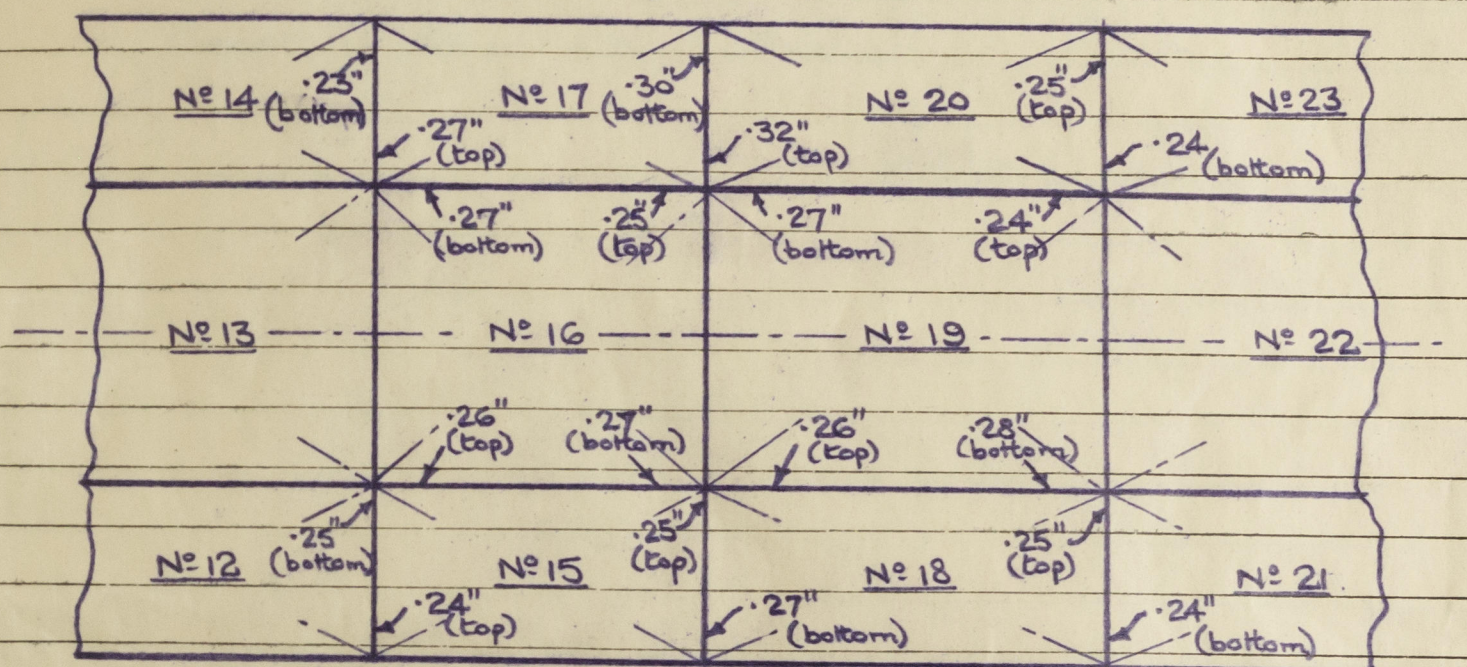
Note :- A provisional test hole was drilled in both strakes of plating of each of the transverse and longitudinal bulkheads between the deep tanks amidships and gauged as shown in plan below.

Original thickness of above bulkhead plating as per builders drawings is 12 lbs. (approx. .30" plating).
