REPORT OF SURVEY FOR REPAIRS, &c.

Date of writing Report 8th July 1950 When handed in at Local Office 10 Port of LIVERPOOL
 No. in Reg. Book 22740 Survey held at BIRKENHEAD Date, First Survey 13/4/50 Last Survey 16/6/1950
 on the Wood, Iron or Steel S.S. "PROSPECTOR" (No. of Visits 21)

AIRS, OR EXAMINATION AS PER RULE, FOR DAMAGE - CONDITION - O.F. CONVERSION.

5.5. "PROSPECTOR"

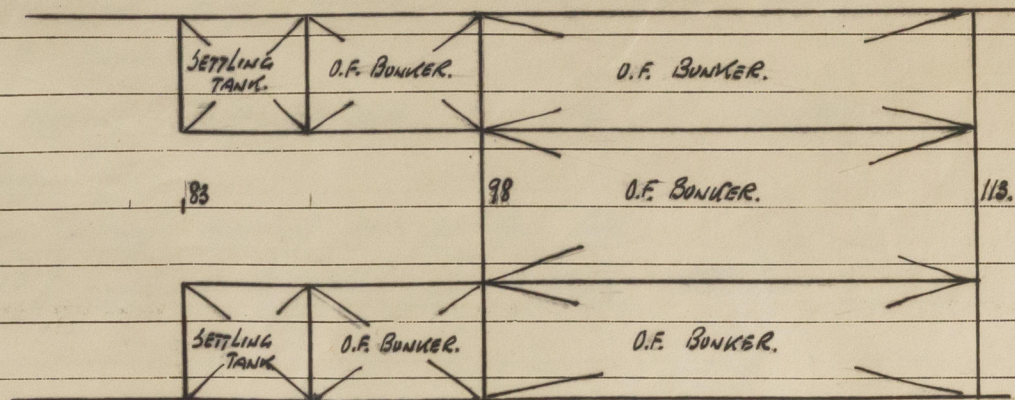
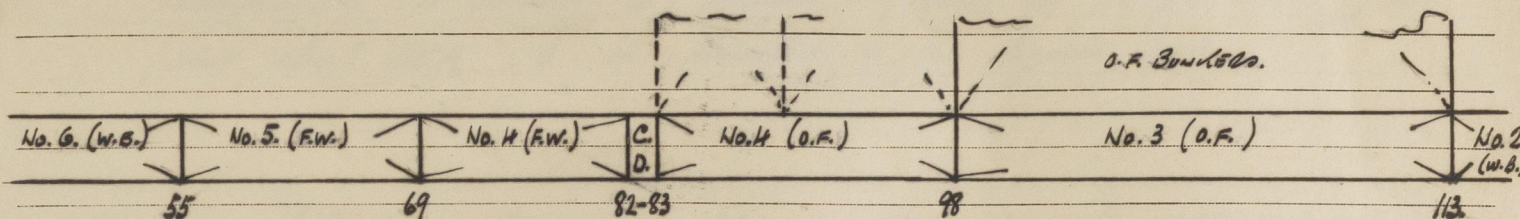
— PLAN VIEW - ARRANG^t OF
O.F. BUNKERS. —

O. B. tanks rearranged as shown in sketch.

Existing structure removed - Bulkheads 98 and 113 from tank top to lower deck, side coal bunkers, deck plating, girders and hatch beams.

main O.F. bunkers constructed between fcs. 98 and 113 - side bunkers and settling tanks P.S. between 83 and 98, all in accordance with approved plans and Section 20 of the Rules.
