S.S. 'JANO'

DESCRIPTION OF DAMAGE AND TEMPORARY REPAIRS RECOMMENDED

SKETCH OF FOREPART
OF S.S. 'JANO'

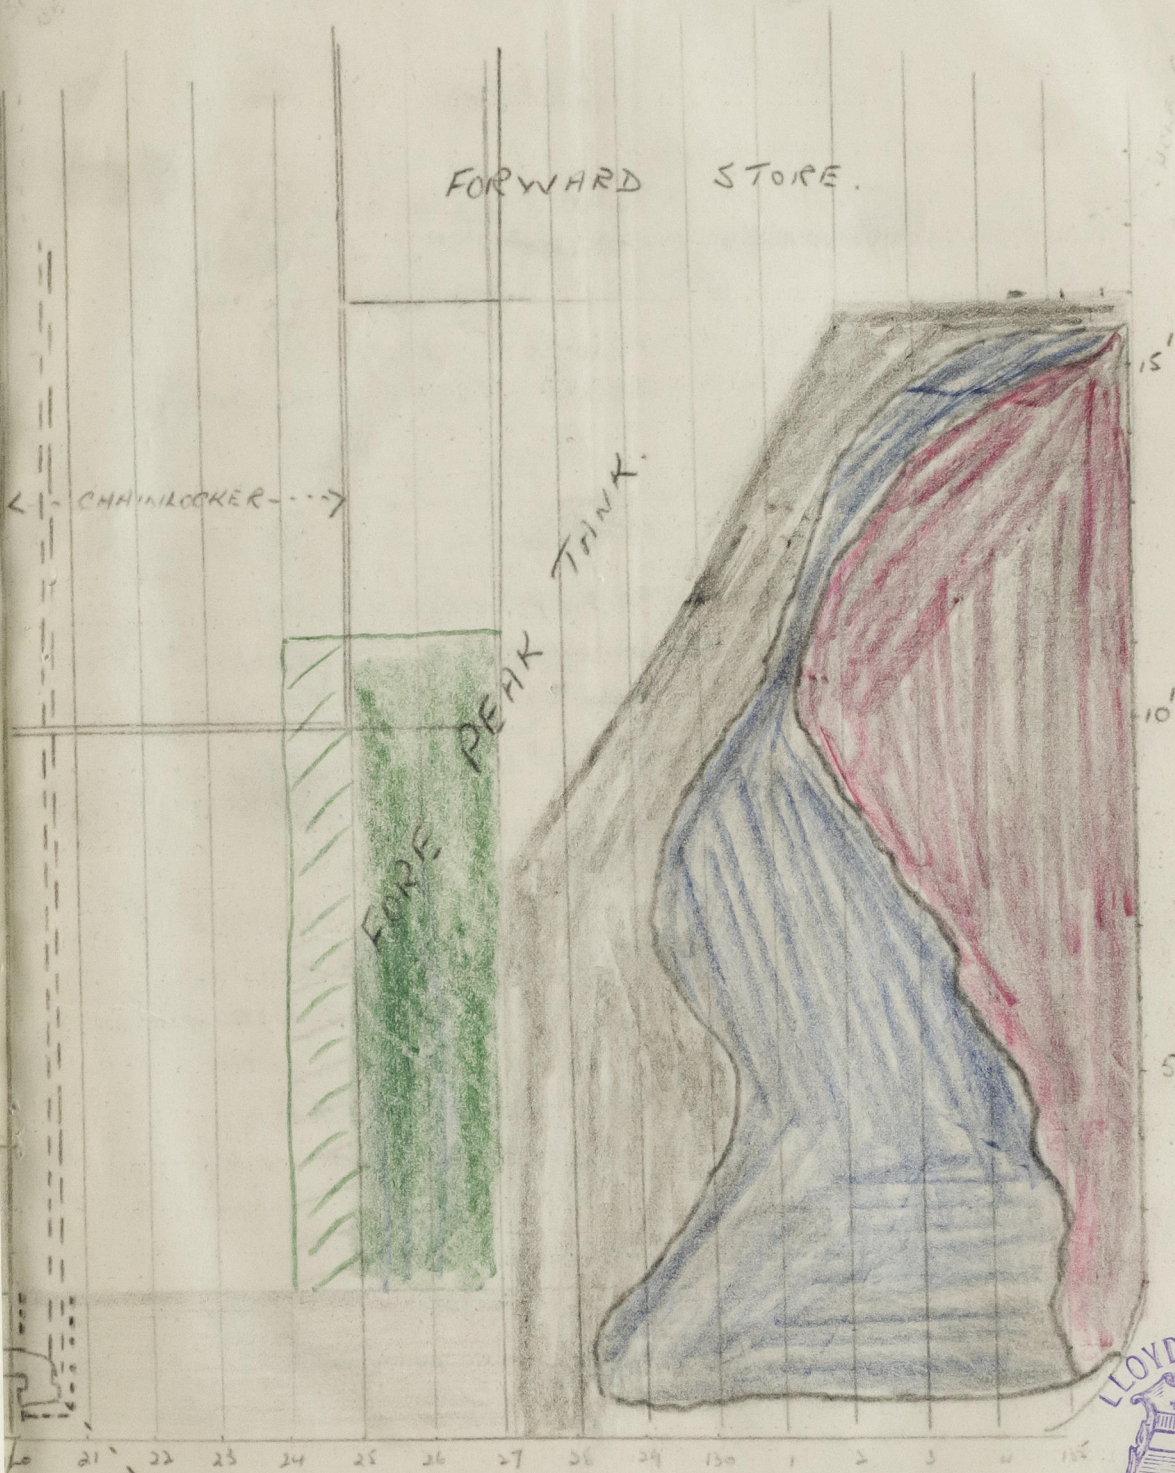
PART OF BOW WALL
IS MISSING.

TORN, BENT OR COLLAPSED
FRAMES, PLATING ETC.

CEMENT IN FRAME SPACES ON
PORT & STARBOARD SIDES.

CEMENT IN FRAME SPACE
ON PORT SIDE ONLY
