Survey held at Birkenhead.

REPORT OF PERIODICAL SURVEYS & REPAIRS OF MACHINERY

No. in R.B. 83013. Name M.V. "TROCHISCUS" S.S. Gross tons 10685 Date of build 1944

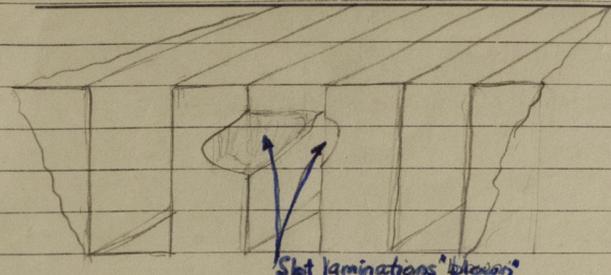
Sketch showing Damage Sustained. FIG 1

Forward Bottom Slots of Main Propulsion Motor Stator.

Thirty stator coils were removed and the damaged slot laminations examined. Two (Ford Bottom) slots had been affected and it was recommended that a section of the slot laminations 1" x 2 1/16" should be cut away and the space blocked with a piece of White Sindanyo. The "blocking piece" to be doweled to a steel check piece which was to be secured to the existing core plate by welding. The adjacent core plate teeth had suffered only slight damage and were to be built up with welding and the finish ground. Two slight voids in the slot laminations were to be filled with commutator cement (see sketches).

The above recommendations were carried out and prior to the completion of the rewinding of the section of coils the rotor was turned and damaged the evolutes of existing coils this caused the removal and replacement of a further sixteen stator coils.

Before connecting the forty-six new coils to the rest of the stator windings they were pressure tested at 5.6 KV. and on completion of the repair the stator winding was pressure tested at 2.5 KV. all with satisfactory results.
