S/S "CLAN MURRAY"

AT MANILA, 28th OCTOBER/3rd NOVEMBER, 1962.

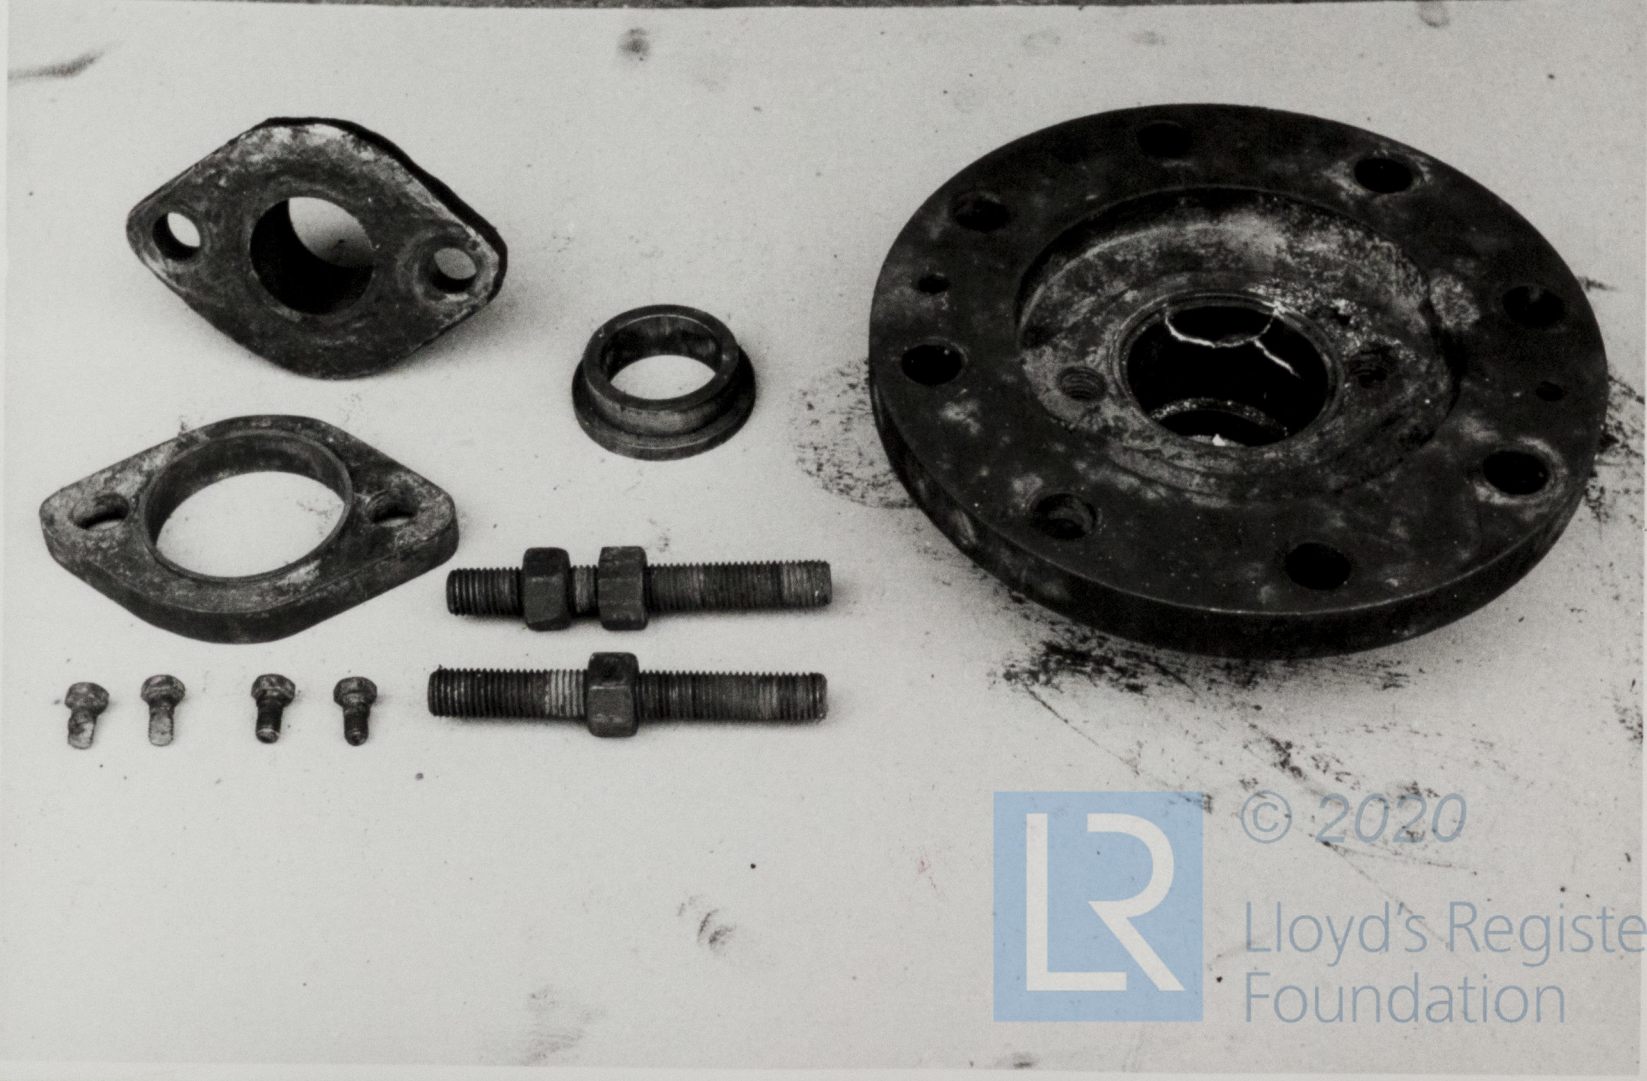
Forward Boiler Feed Pump Cover, water end, showing the fractured improvised brass bushing, the wasted material in way of the gland stud and the improvised gland cover to hold the fractured gland bushing in position. This cover, (C.I.) had also been previously repaired on the underside.
