# REPORT OF SURVEY FOR REPAIRS, &c.

Date of writing Report 21st May 55 When handed in at Local Office 21st May 55 Port of Manchester  
 No. in Reg. Book 50553 Survey held at Manchester Date, First Survey 7th May 55 Last Survey 14th May 1955  
 on the Wood, Iron or Steel SS. "AKTI HILL" (No. of Vists 7)

Built at Sorel P.Q. By whom Maine Industries Ltd. When 1944 MONTH 6  
 Owners North Sota Maine Enterprise Co Ltd Owners' Address (if not already recorded in Appendix to Register Book)  
 Managers Quintess Ship Management Co Ltd Port belonging to London  
 surveyed Afloat or in Dry Dock? Drydock Name of Dock Nº1 Drydock, MSC Destined Voyage \_\_\_\_\_  
 Cell D Bor D Ba \_\_\_\_\_ feet; uE&B \_\_\_\_\_ feet; f \_\_\_\_\_ feet  
 total capacity \_\_\_\_\_ tons. FPT \_\_\_\_\_ tons; APT \_\_\_\_\_ tons; MT \_\_\_\_\_ feet \_\_\_\_\_ tons.

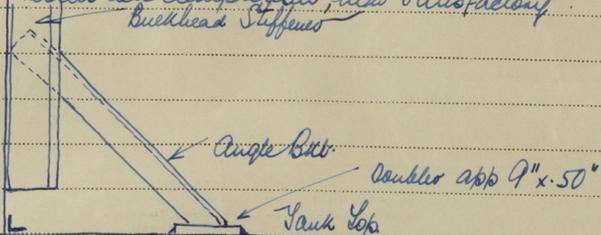
Deep Tank Starboard leaking into No 7 Oil Fuel Tank.

New Case:- Starboard Deep Tank examined intensively and small fracture found at base of Bulkhead Stiffener angle bracket to Tank Top (After Bulkhead) at the 4th and 6th Bracket from Tunnel Side. Angle brackets to all Stiffs cropped and doubles approx 9" broad x 50 lbs welded to Tank Top and Stiffs welded to doubler. Fracture welded and Tank tested on completion, now satisfactory.
