Date of writing Report 8-8-59

Survey held at Rotterdam

REPORT OF SHIP SURVEYS AND REPAIRS

"THE ODOXUS"

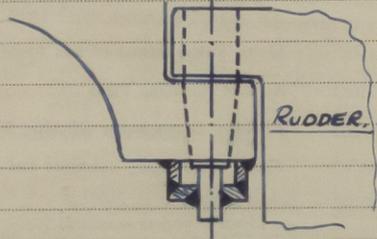
Further toppintle of rudder was found slack, nut of same lost and thread on pintle worn.

As the vessel was indented to be laid up in an Irish Port, the Owners requested to postpone examination of the tapered hole in the gudgeon and renewal of pintle until the vessel will be put into commission after the laying-up period.

Meantime the pintle was hardened up now and well secured by a strong electric welded ring (as per sketch) and this arrangement is in my opinion efficient meantime, but it is recommended toppintle of rudder etc. to be permanently repaired when the vessel will be put into commission after the laying-up period.
