REPORT OF SHIP SURVEYS AND REPAIRS

No. in R.B. 18069. on the Iron or Steel M.S. S.S.X. "KIRSTEN SKOU". Tons gross 4.153. Year 1953. Month

EXAMINATION AND REPAIRS AS PER RULE FOR Damage repairs to lubricating oil tanks, cause not stated.

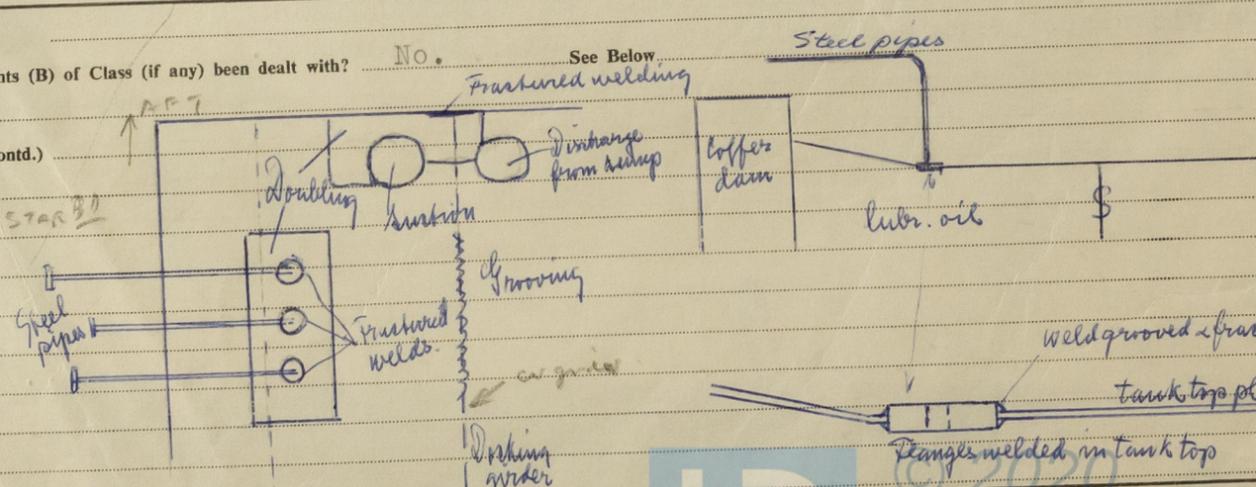
Now done: Lubr. oil tanks and cofferdams (double bottom tanks) cleaned, examined, and tested. Three floors starboard side found slightly buckled at bottom. Leakage found in tanktop in way of welded connections for three pipes starboard side below flywheel and at centre after end in weld to end bulkhead, forward of tunnel. The above three pipes are connected to tanktop as shown on sketch and welding was found corroded and fractured.

Tanktop plating found pitted especially in way of docking girder and in way of suction pipe after end.

Repairs: The fractured welding now cut out in way of bulkhead after end and pipe connections, rewelded and doublings fitted starboard side in way of pipe connections and between end bulkhead and suction pipe. Pitting on tanktop plating built up by welding, lubr. oil tanks tested on completion of repairs and found good.
