Date of writing Report 24th September 1960 When handed in at Local Office

Survey held at Taranto

REPORT OF SHIP SURVEYS AND REPAIRS

No. in R.B. 68746 on the Iron or Steel M.S. S.S. "LA FLECHE"
 Built at Laizon By Whom Davie S.B. & Rep. Co. Ltd. Tons gross 7131
 Year 1943 Month 6
 Owners Cia. Atlantica Pacifica S.A. Owners' address =
 (If not already in R.B.)
 Managers = Port of Registry Panama
 Surveyed Afloat or in Drydock afloat Name of Dock = Date of last examn. in Drydock =

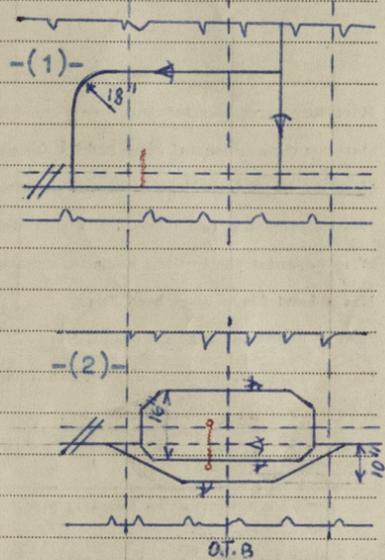
Plate in 2nd strake below sheerstrake, 9th from aft. p.s., fractured for about 9" in way of lower seam between 1st and 2nd frs. from after butt.

Plate in 2nd strake below sheerstrake, 10th from aft. p.s., fractured for about 7" in way of lower seam between the bunker's O.T. fwd. bulkhead and 1st fr. fwd.; fracture extended to lower plate for about 5".

Now: Part of plate renewed by 60"x35"x.6" insert, as per sketch (1)

Now: Welded doublers fitted as per sketch (2) after drilling holes at ends of fractures.
