Date of writing Report 24-3-1960

Survey held at SCHIEDAM

# REPORT OF SHIP SURVEYS AND REPAIRS

"TECTUS"

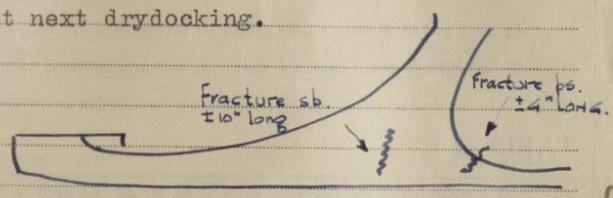
Fractures were now observed in sternframe port and starboard side (for position and extent see sketch) and have been veed out and repaired by electric welding (all usual precautions taken regarding protection of welding against weather conditions, pre-heating and slowly cooling down after welding).

Welded surfaces have been ground smooth upon completion.

It is submitted sternframe (e.w. 3-60) to be specially examined at next drydocking.
