"TECTUS".

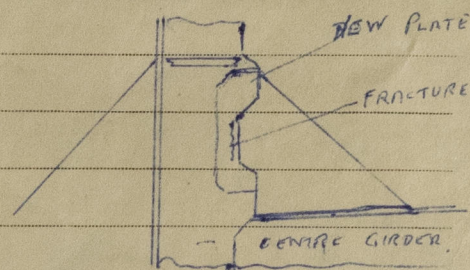
Web plate cropped and part renewed where buckled locally and fractured at corrugation in No.5 centre tank, port web between bottom and centre brackets and No.2 centre tank port web between bottom and centre brackets.

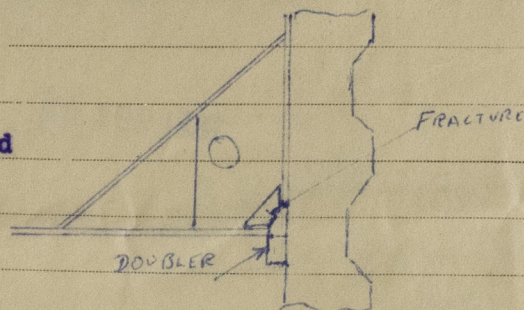
Bracket connecting centre web to centre girder, short crack at inner edge of bracket plate veed-out, welded and shaped doubler fitted. Compensating stiffener fitted to bracket plate in way in No.9 centre tank centre web keelson bracket, and No.8 centre tank centre web keelson bracket.
