# REPORT OF SURVEY FOR REPAIRS, &c.

on the ~~XXXXXX~~ Steel Twin Screw m.t. "ESSO KÖBENHAVN"  
TONNAGE: — Built at Newcastle By whom Palmer's Co. Ltd. YEAR. MONTH. 1930 11  
GROSS 12062 Owners Dansk Esso A/S Owners' Address \_\_\_\_\_  
NET DK. 11449 Managers — \_\_\_\_\_  
7146 Managers' Address \_\_\_\_\_  
If not already recorded in Appendix to Register Book

REPAIRS, OR EXAMINATION AS PER RULE FOR SPECIAL SURVEY AND DAMAGE S.S. due 9.56 Ship now 24 years old  
Age stated to have been sustained by mine explosion in the Great Belt (Denmark) on 25th December, 1953.

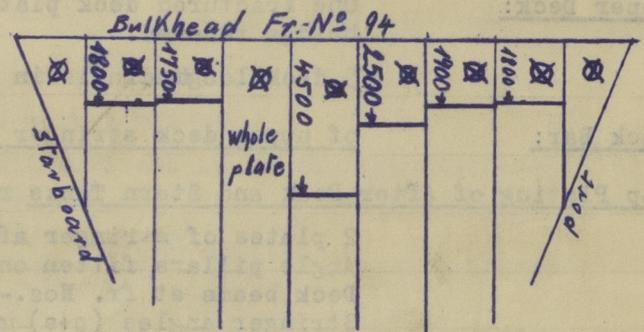
Deep tank fwd. top plating: p.s. 8.5, 9.5, 9.5, 9.0, 6.5, 7.0, 9.5, 10.5, 7.5 s.s.  
All plates of 8.5 mm and less have now been renewed.

Deep Tank fwd. Top Plating renewed as per sketch.

⊗ = renewed
