# REPORT OF SURVEY FOR REPAIRS, &c.

Date of writing Report 27. 8. 1950 When handed in at Local Office 5 SEP 1950 Port of Liverpool  
 No. in Survey held at Birkenhead Date, First Survey 19/5/50 Last Survey 27/7/1950  
 Reg. Book. 78697 on the Woolwich Steel S.S. "TETELA" (No. of Visits 16)

REPAIRS, OR EXAMINATION AS PER RULE, FOR CONDITION - O.F. CONVERSION - DAMAGE.

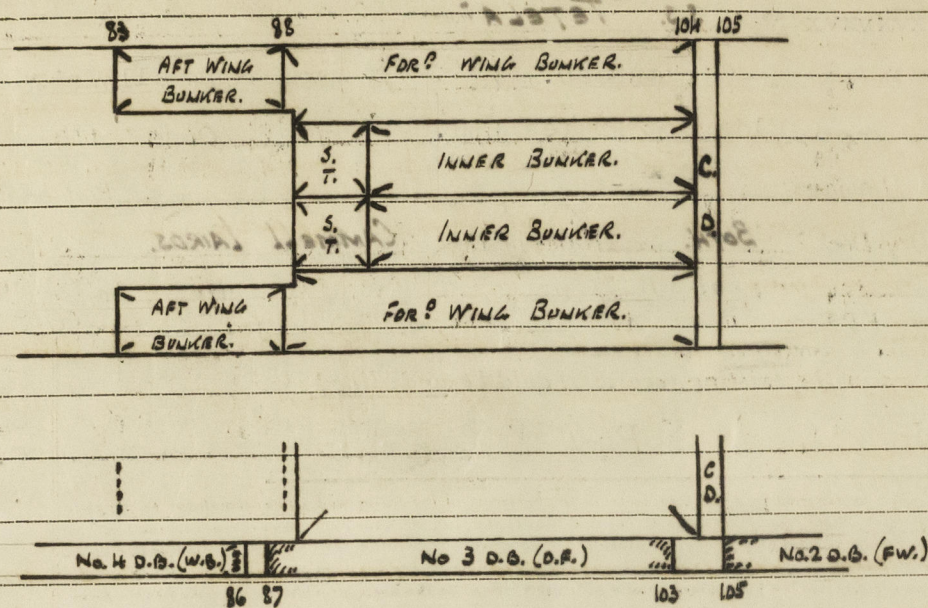
O.F. CONVERSION. Arrangement provided for the carriage of oil fuel in No. 3 S.B. tank and in

six deep tanks and two settling tanks; the general scheme is shown on sketch.

After wing deep tanks (P.S.) O.F.	Total	101.8 tons O.F.
Forward " " " O.F. or W.B.	523.6	(576 T. W.B.)
Centre deep tanks (P.S.) O.F.	467.0	" "
Settling tanks (P.S.)	140.0	" "
No. 3 D.B. tank	130.6	" "
Total	1363.0	tons O.F.

brackets. Existing side bunker bulkheads cut down to form a deep girder P.S. Existing main deck removed in way of new bunkers. New oil fuel deep tanks and settling tanks constructed and fitted all in accordance with the approved plans, and with Section 20 of the Rules.

No. 3 D.B. tank arranged for the carriage of O.Fuel. Tanks clipped to bare steel internally, and cofferdams arranged, forward & aft at frames 86/87 and 103/105, the existing floors being satisfactorily stiffened to form tank ends. Additional stiffening, in the form of intercostals
