REPORT OF SURVEY FOR REPAIRS, &c.

Built at SOUTH BANK, MIDDLESBROUGH By whom Smiths Dock & Co. Ltd. When 1930

REPAIRS, OR EXAMINATION AS PER RULE FOR SPECIAL SURVEY "D" DAMAGE & OIL FUEL CONVERSION SPECIAL SURVEY DUE 3/56 VESSEL 26 YEARS AND 3 MONTHS OLD

" K Y L O E "

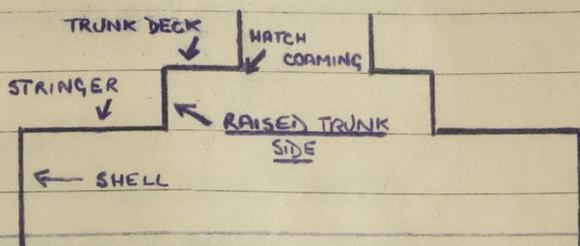
UPPER DECK, DRILLINGS (AFT OF BRIDGE) FRAMES 48 - 49

STRAKE	PORT	STARD	ORIGL
DECK STRINGER	50 •62"	50 •64"	•74" ✓
RAISED TRUNK SIDE	•44"	•48"	•50" ✓
RAISED TRUNK DECK	•50"	•50"	•54" ✓
