REPORT OF SURVEY FOR REPAIRS, &c., OF ENGINES AND BOILERS

No. in Survey held at Jarrow on Tyne Date First Survey 15.4.46 Last Survey 6.8.1946
 Reg. Book. 86137 on the Machinery of the Wood, Iron or Steel 1/2 "CHARLES DICKENS" ex "Gryfevale" (No. of Visits 30)

S/S "CHARLES DICKENS"

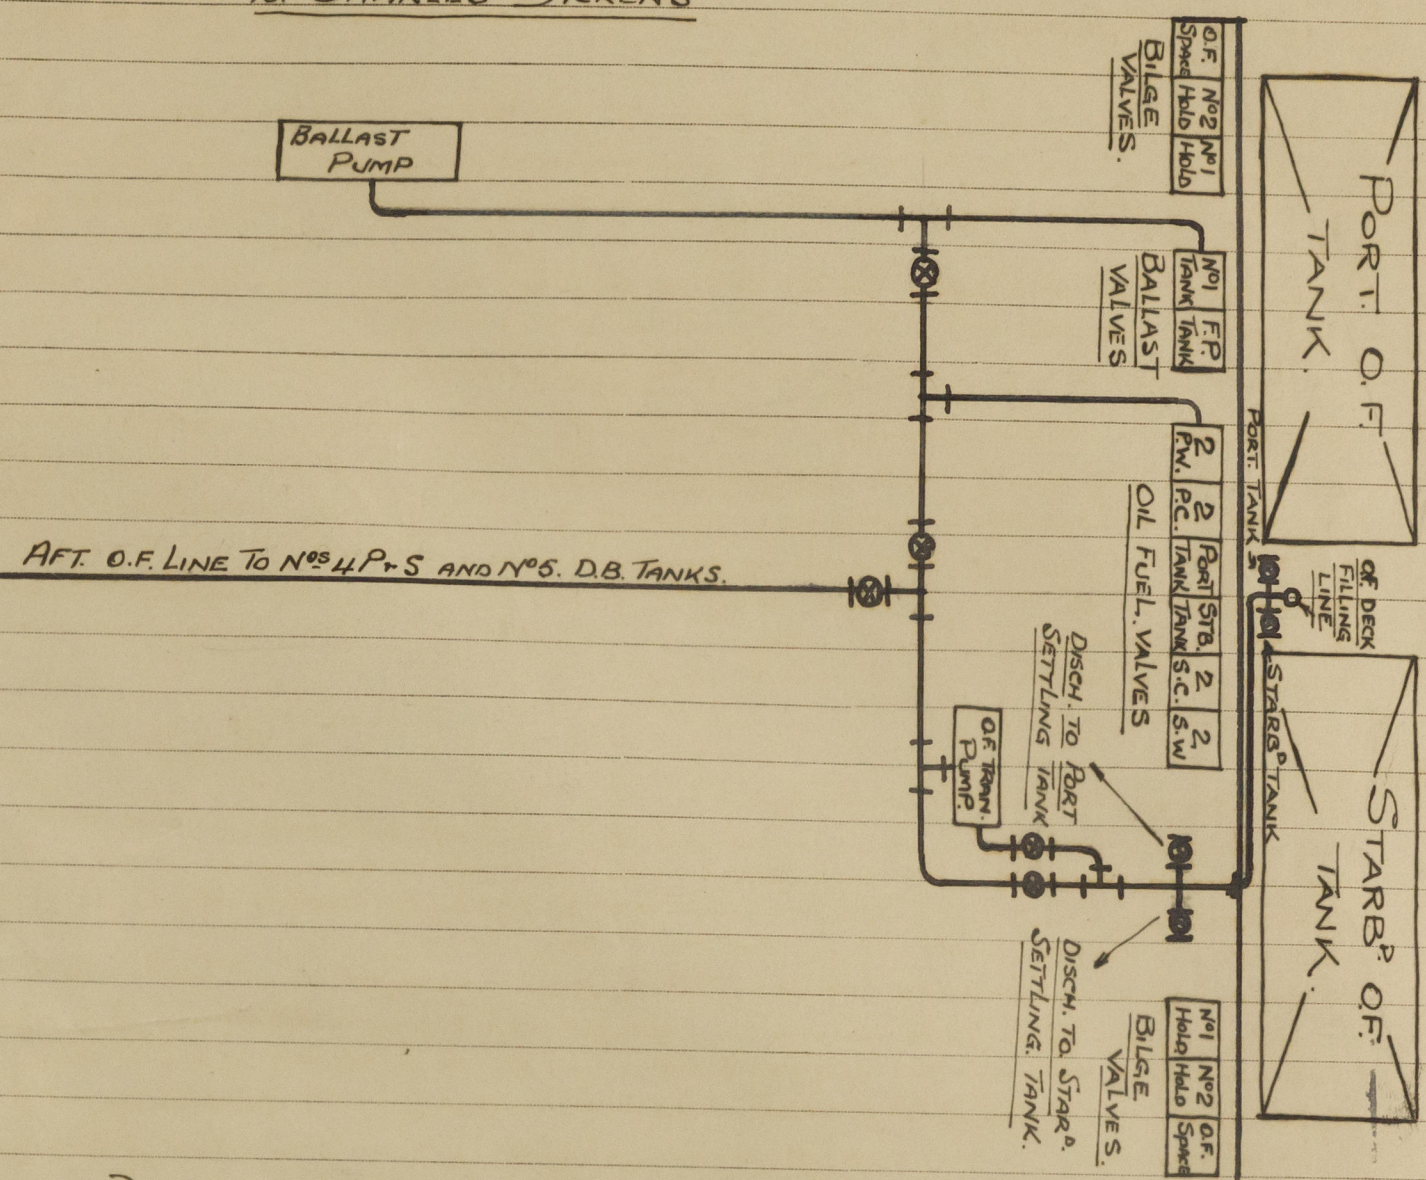
DIAGRAMMATIC SKETCH OF CONNECTIONS MADE AT THIS TIME FOR PART CONVERSION FROM COAL TO OIL FUEL BURNING.

Existing ballast line to No. 4 P. & 5 tanks now connected as shown in the accompanying sketch, owing to the isolation cocks recommended in the approved drawing being unobtainable. The owner's superintendent states that this line will be altered to conform to the drawing before the conversion is completed.

Oil fuel transfer pump installed in stokehold and connections made as shown in accompanying sketch. It is stated by owner's superintendent that the conversion to oil fuel burning will be completed as the opportunities occur.
