M/T "S V I T H I O D", No. 28732 in the Register Book.

REPAIRS NOW EFFECTED DUE TO WEAR AND TEAR:-

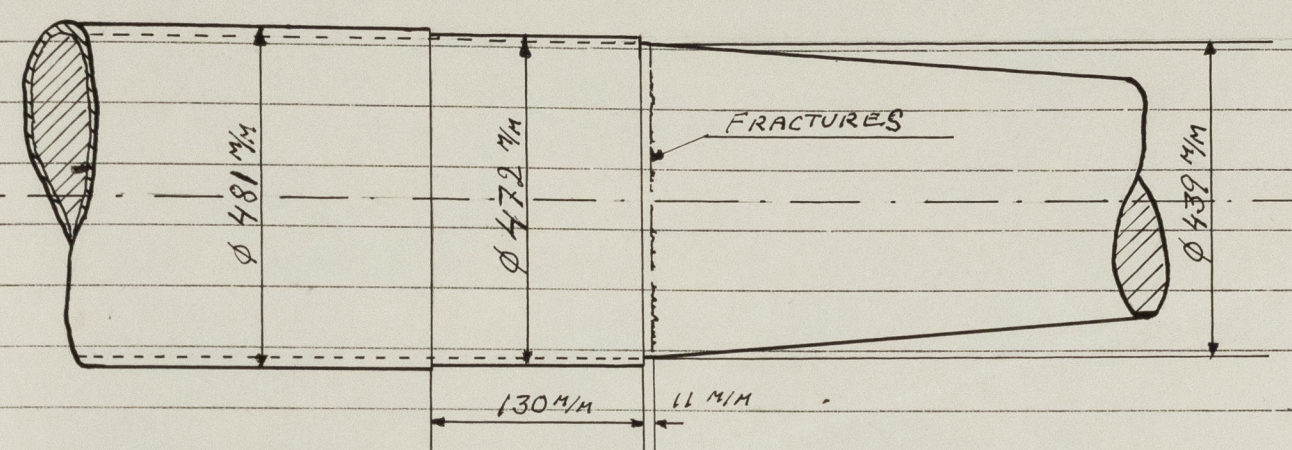
The propeller shaft found pitted and fractured at after end of liner in vicinity of cone. (Please see sketch and attached photo.)

The propeller shaft was rejected and the spare propeller shaft, marked:-

LLOYD'S NO. 176

B-n 8.6.50.

has been fitted.

Lignum vitae in the stern bush renewed.
