REPORT OF SHIP SURVEYS AND REPAIRS

Ship's Name SS/M "INDIAN ENDEAVOUR" (LR 516027)

Rpt. No. 2030

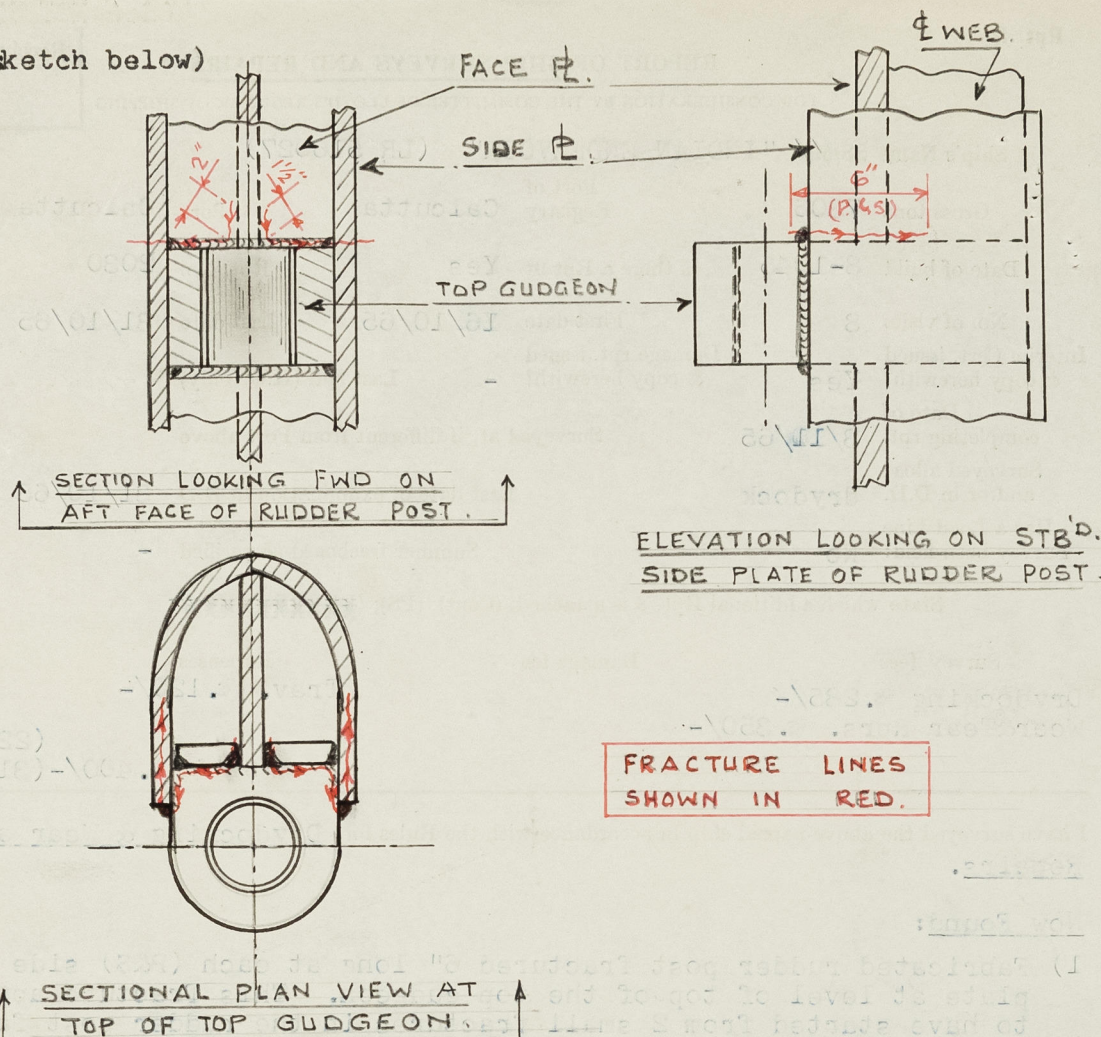
- 1) Fabricated rudder post fractured 6" long at each (P&S) side plate at level of top of the top gudgeon. This fracture appears to have started from 2 small fractures in the rudder post face plate in way of the internal centreline web plate and to have extended down and into the top welding of the gudgeon to the face plate, and thence to port and starboard along the welding of the gudgeon and into the side plates. No serious corrosion or wastage found in the structure of the sternframe or in the welding of sternframe and gudgeon in way of these fractures but considerable wastage found in the rudder trunk and deck plating at top of the trunk supporting the pallister bearing in the steering flat. Also, the top pintle found slack in this gudgeon on account of wear down of the lignum vitae strips in the rudder post gudgeon (0.23" clearance). It is considered that this serious fracture could have been the result of vibration on account of slackness of the top pintle, and flexibility of the pallister bearing seating on account of serious wastage.

(See sketch below)

Now done for permanent repairs

- Rudder lifted and removed.
- Rudder post side plate fractures veed out to 60° bevel and hand dressed smooth and 3/8" dia. stopper holes drilled at end of fractures.
- Fractured welding of top of gudgeon to face and side plates of rudder post removed and dressed off clean of all old weld deposit.
- Fractured face plates of rudder post cropped approximately 9" above top of gudgeon each side of internal centreline web plate and 2 pieces removed giving access for internal examination and internal sealing weld to the fractured side plates.
