REPORT OF SURVEY FOR REPAIRS, &c.

Date of writing Report 21st February 1949 When handed in at Local Office 27th Feb. 1949 Port of NEWCASTLE-ON-TYNENo. in Reg. Book. 62038 Survey held at Garraw. on Tyne Date, First Survey 29th Sept. 1948 Last Survey 31st January 1949 (No. of Visits 32)on the Wood, Iron or Steel S/S "HILARY" By whom CAMMEL, LAIRD & CO. LD When 1931 MONTH 8TONNAGE: — Built at BIRKENHEAD Owners' Address BOOTH S.S. CO. LDGROSS 7420 Owners' Address BOOTH S.S. CO. LD (If not already recorded in Appendix to Register Book)UNDER DK 6184 Managers BOOTH S.S. CO. LD Port belonging to LIVERPOOLNET 4268 Managers BOOTH S.S. CO. LD Port belonging to LIVERPOOLSurveyed Afloat or in Dry Dock? BOTH Name of Dock PALMER'S GARROW Destined Voyage

In damage cases where the Surveyor has not made a special damage report he is required to state whether he offered his services for this purpose and to whom and why they were declined YESNOT REQUIRED Was a damage report made by anyone else? if so, by whom? UNDERWRITER SURVEYORREPAIRS, OR EXAMINATION AS PER RULE, FOR DAMAGE, AND CONVERSION TO OIL FUEL BURNING

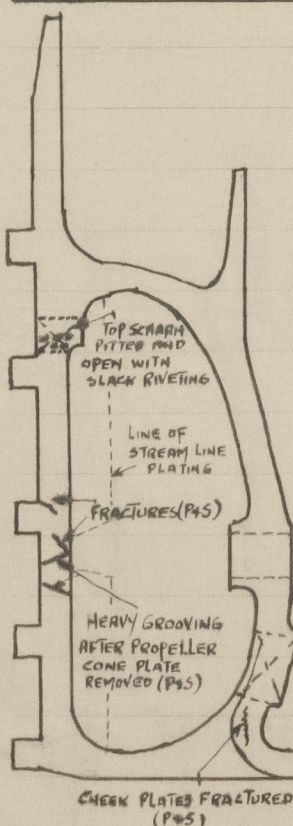
The stream line plating at sternframe found fractured and corroded at several places. On removal of this plating, deep fractures and grooving were found on sternframe as indicated on sketch. The top Scarph also found deeply pitted and open on face and riveting slack.

The cheek plates below boss fractured in way of rivet holes.

All the fractures and grooving and pitting efficiently vee'd out and electrically welded.

The fractured cheek plates cropped and partly renewed with increased thickness of plating, and extended further along sole piece of sternframe.

The top Scarph split, examined, cleaned and re-riveted. Pittings in way elect. welded.

It is recommended that sternframe (E.W. in way of N^o 3 gudgeon 1, 4, 9) also top Scarph be specially examined at next drydocking.
