REPORT OF SURVEY FOR REPAIRS, &c.

Date of writing Report 1/4/40. When handed in at Local Office 1/4/40. Port of GENOA.
 No. in Survey held at GENOA. Date, First Survey 23/3/40. Last Survey 29/3/40. 19x
 Reg. Book. 24939 on the W 660, Iron or Steel Sc. "GIULIA"
 (No. of Visits Five.)

TONNAGE:— Built at Monfalcone By whom Cant. Nav. Triestino When 1926 1
 GROSS 5921 Owners "Italia" S. A. di N. Owners' Address —
 UNDER DEK 4955 Managers — Port belonging to Genoa
 NET 3737

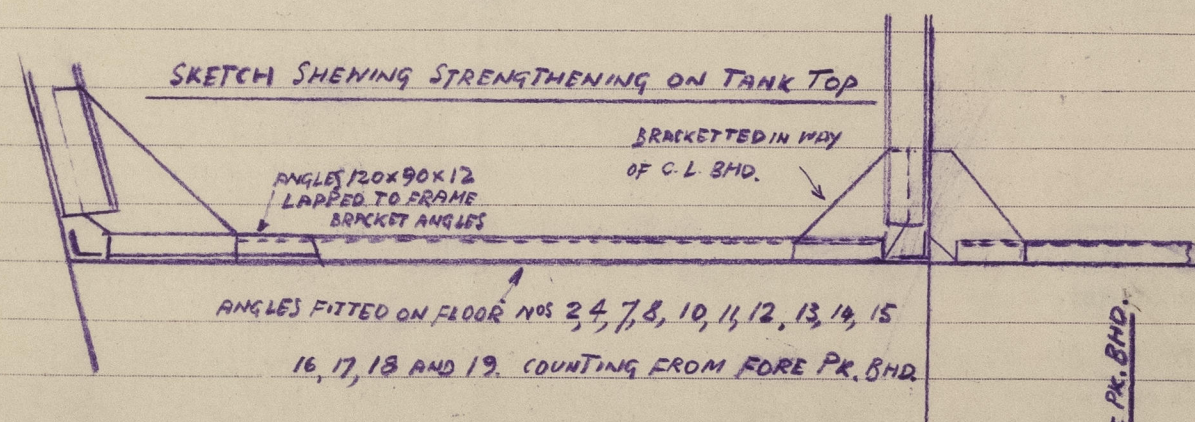
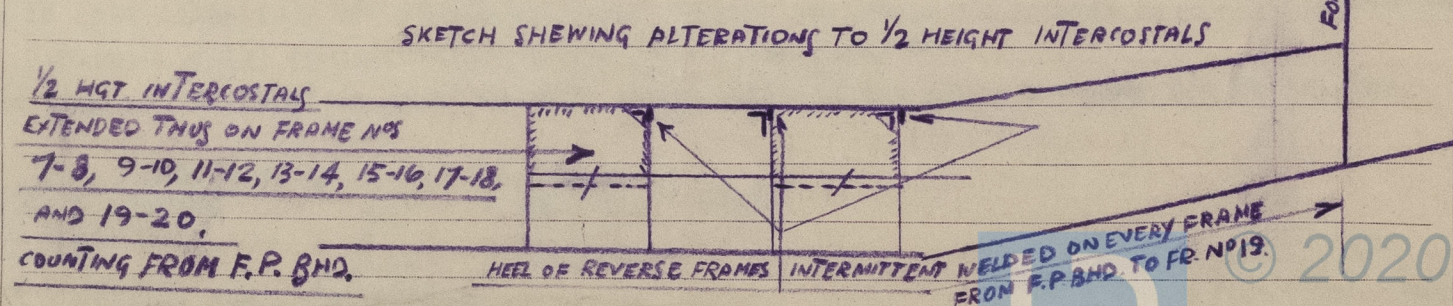
- 1) - No.2 keel plate referred to above has been renewed 2 m/m thicker than previously.
- 2) - The half height intercostal side girder in No.1 D.B. Tank was made full height on alternate frame spaces for 7 frame spaces by fitting plate welded to inner bottom and rivetted to existing half height intercostal. See sketch.
- 3) - In line with D.B. tank floors, 120 x 90 x 12 angle bars were fitted, ~~WELDED~~ to tank top plating and extending across tank top and lapped to extended angle on frame bottom brackets. In way of centre line bulkhead the bars were bracketted to bulkhead. In addition the heels of reverse bar from 1-19 were reinforced with electric welding (See sketch). The Owners stated that this strengthening was carried out as it had been noted vessel pounded heavily forward during light ship voyages.
