## REPORT OF SURVEY FOR REPAIRS, &amp;c.

Survey held at Jarrow on Tyne

S/S "GRANDYKE" TO BE RENAMED "BENVANNOCH"

DAMAGE, SPECIAL SURVEY AND CONVERSION TO OIL FUEL BURNING

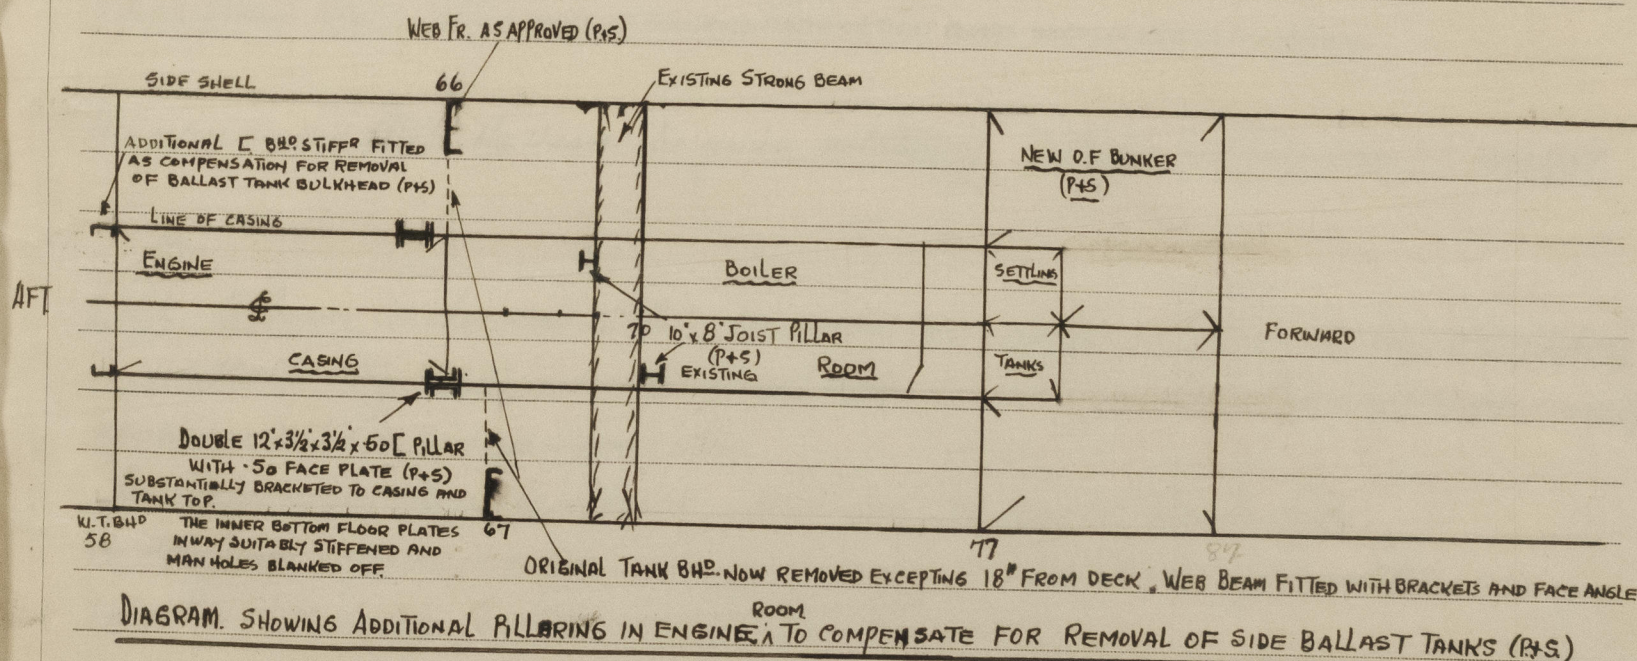
Portions of the forward transverse bulkhead of tanks retained as a web frame in agreement with the approved plan. In conjunction with these side web frames 2 channel pillars (IP, IS) consisting of double  $12 \times 3\frac{1}{2} \times 3\frac{1}{2} \times 50$  channels with 50 face plates introduced extending from tank top plating to 2<sup>nd</sup> deck to compensate for removal of the ballast tanks. (See sketch below)

It is recommended that the Register Book be suitably amended with regard to the removal of these tanks.

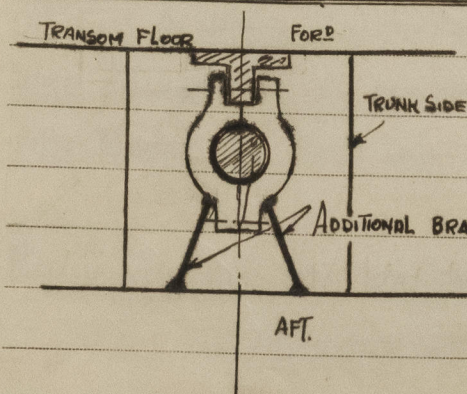
RUDDER STOCK BEARING IN RUDDER TRUNK

RUDDER. Examined in lifted position. The bottom pintle bush and the top steadment bearing bush renewed.
