## REPORT OF SURVEY FOR REPAIRS, &amp;c., OF ENGINES AND BOILERS

No. in Reg. Book. **11136** Survey held at **Jarrow-on-Tyne** Date First Survey **4th Sept 1949** Last Survey **16th Jan 1950**  
 on the Machinery of the **Wood, Iron or Steel** **5/5 "Grandyke" to be named "Bennoamock"** (No. of visits **33**)  
 Gross **7069** Vessel built at **Sunderland** By whom **Shipbuilding Corp. Ltd (Wear Branch)** When **1944** Year. Month.  
 Net **4079** Engines made at **Dumbarton** By whom **Wm Denny & Bros. Ltd** When **1944**  
 Nominal Horse Power **510 MN** Boilers, when made (Main) **1944** (Donkey)  
 No. of Main Boilers **35B (4ft)** Owners **Ben Line Steamers Ltd** Owners' Address **London to be altered Voyage**  
 No. of Donkey Boilers **✓** Managers **Wm Thomson and Co** Port **London to be altered Voyage**  
 Steam Pressure in Main Boilers **220 lbs** If Surveyed Afloat or in Dry Dock **Afloat & in dry dock at** Particulars of Classification (which must be inserted precisely as in Register Book & Supplements).

GRANDYKESHEET N<sup>o</sup> 3.

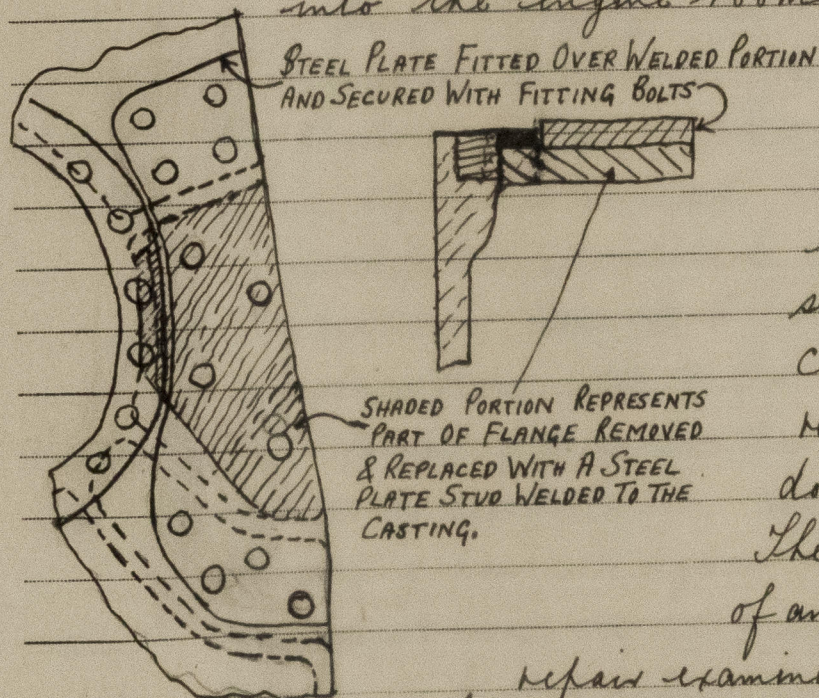
Damage No 4. An examination now carried out on account of damage stated to be caused to the M.P. cylinder top flange on 22/12/49 whilst repairs were in progress, by gear slipping out of the sling and striking the cylinder whilst being lowered by the crane into the engine room.

The top flange found to be fractured in several places on the starboard side (See sketch). The fractured pieces removed and a piece of steel plate fitted & stud welded to the cast iron. The whole covered by a reinforcing steel plate  $\frac{3}{4}$ " thick bedded down & secured with  $1\frac{1}{8}$ " fitted bolts.

The cylinder wall specially exd. & no evidence of any fractures found. On completion the

repair examined under steam & found to be efficient. It is recommended that the repair be considered permanent without any restriction in respect of Special Exms.
