REPORT OF SURVEY FOR REPAIRS, &c.

Date of writing Report 21 APR 1958 19 When handed in at Local Office 19 Port of Nagasaki
 No. in Reg. Book 22728 Survey held at Nagasaki Date, First Survey 17th Feb. Last Survey 7th March 1958
 on the Wood/Iron/Steel S.S. "OAKBY" (No. of Visits 10)

TONNAGE:-
 GROSS 7140 Built at P. Me By whom Todd Bath Iron S.B. Corp. When 1942 YEAR MONTH 6
 UNDER DK - Owners Ropner Shipping Co., Ltd. Owners' Address -
 NET 4383 Managers Sir R. Ropner Co. (Management) Ltd. Port belonging to West Hartlepool

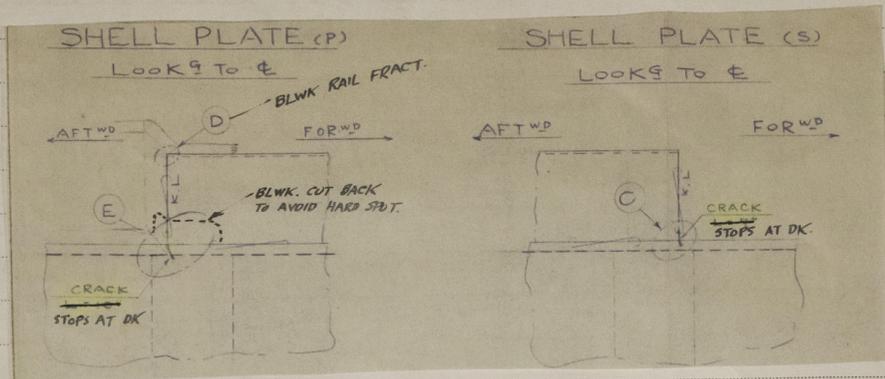
Structure on Sheerstrake Amidships (p & s)
 Top of the sheerstrake (p & s) fractured immediately in the line of the after end plate of accommodation ladder recess in bulwarks. This end plate and bulwark plating is welded direct to the top of the sheerstrake and the fracture extends into the corner weld of recess plating. Fracture in sheerstrake does not extend below the line of deck plating which is welded to sheer.
 P.T.O.

(Note:- From the appearance of this fracture it is considered that it has been in existence for some considerable time).

The fractures now cut out drilled at end and re-welded. On the port side it was necessary to crop and part renew the deck stringer plate in way.

The bulb angle rail bar welded where fractured at this corner.

In an effort to avoid this local hard spot the bulwark plating and end plate of recess have been cut back from the corner and top edge of sheer allowed to pass freely. On completion all welding dressed off, top of sheerstrake especially, finally hose tested on port side and repairs found tight
