REPORT OF SURVEY FOR REPAIRS, &c.

No. in Survey held at Rotterdam Date, First Survey 9-9-50 Last Survey 10-11-1950
Reg. Book. 68841 on the Wood, Iron or Steel m/s "MAYMERE" (No. of Visits 12)

REPAIRS, OR EXAMINATION AS PER RULE, FOR Docking Survey & Special Survey, Conversion Survey

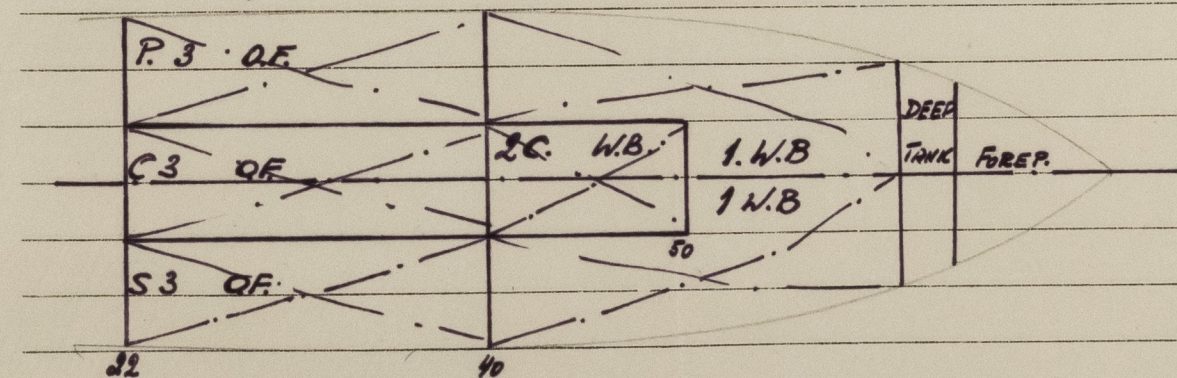
Double bottom has been converted as follows: Forward V.T. floor of cofferdam at frame 51 has been made open, manholes and airholes fitted. Aft. V.T. floor of cofferdam at frame 50 made open, only in way of wing double bottom tank 2, man and airholes fitted. For new arrangement of double bottom, see sketch.
