REPORT OF SURVEY FOR REPAIRS, &c.

Date of writing Report 8th March 1955 When landed in at Local Office 8th March 1955 Port of NAPLES
 No. in Survey held at Taranto Date, First Survey 3rd March Last Survey 5th March 1955
 Reg. Book 02945 on the Steel Twin Sc. M/T "BARBARA" (No. of Visits four)
 TONNAGE: — Built at Hamburg By whom Deutsche Werft AG When 1939 YEAR. MONTH. 3rd
 GROSS 9825 Owners Enrico Insom Owners' Address —
 UNDER DK 8935 Managers — (If not already recorded in Appendix to Register Book)
 NET 5747 Port belonging to Rome

REPAIRS, OR EXAMINATION AS PER RULE FOR damage repairs. Condition.

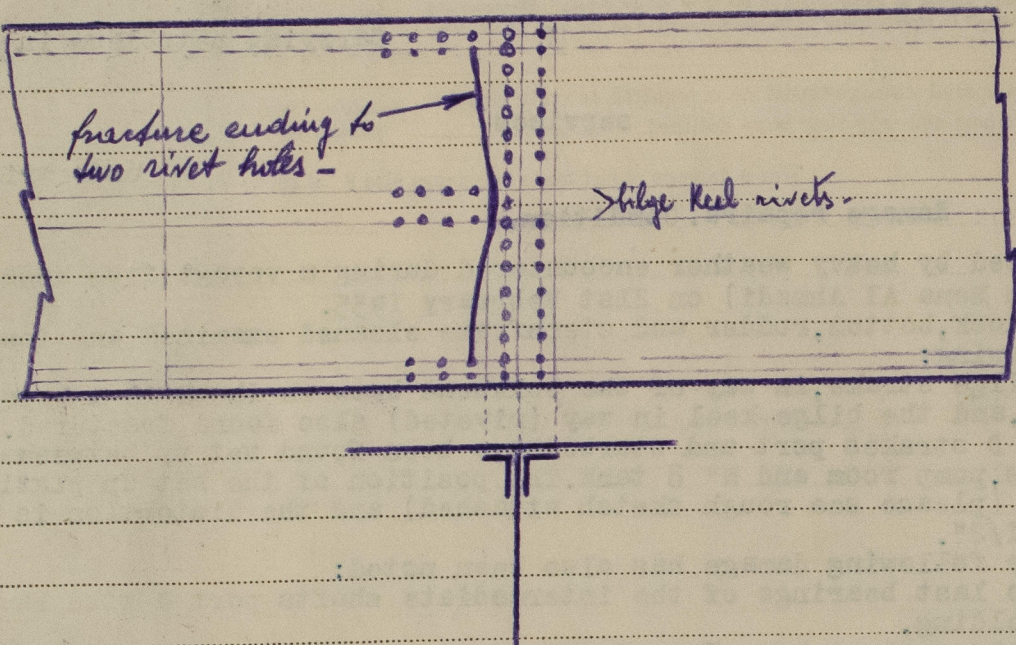
NOW DONE: For damage stated caused by heavy weather encountered during a voyage from Messina to Marseille (coming from Mena Al Ahmadi) on 21st February 1955. Vessel placed in dry dock, bottom, rudder and sternframe cleaned examined and found in good order except the following:
 A plate of the port bilge strake, in way of the bulkhead between the N° 6 & 7 port wing tanks found fractured, and the bilge keel in way (riveted) also found fractured. Several plates of the D strakes port and starbd have been found set up between frames in way of N° 6; 7, tanks, pump room and N° 8 tank. The position of the set up plating is symmetrical port and stbd (please see rough sketch attached) and the distortion is ranging from about 3/4" to 1 1/2".
 In the engine room the following damage has also been noted:
 The seating of the two last bearings of the intermediate shafts port & stbd have been found fractured in way of welding.

Fractured plate of
the port bilge stake -

The fractured plate of the bilge strake in way of the bulkhead between N° 6 & 7 port wing tank has been renewed.
The bilge keel in way has been renewed.
Both bearing seating have been rewelded and reinforced with two brackets.
The fractured welds of the two pillars have been chipped out and rewelded.
The fractured frame N° 27 port side has been welded and a reinforcing plate has been fitted by EW, and the frame N° 28 has been repaired by riveting and EW.
The torn zinc plates at the after end have been replaced.
The set in plate of the D strake port side has been faired in place.
The stbd bilge keel has been repaired by EW.

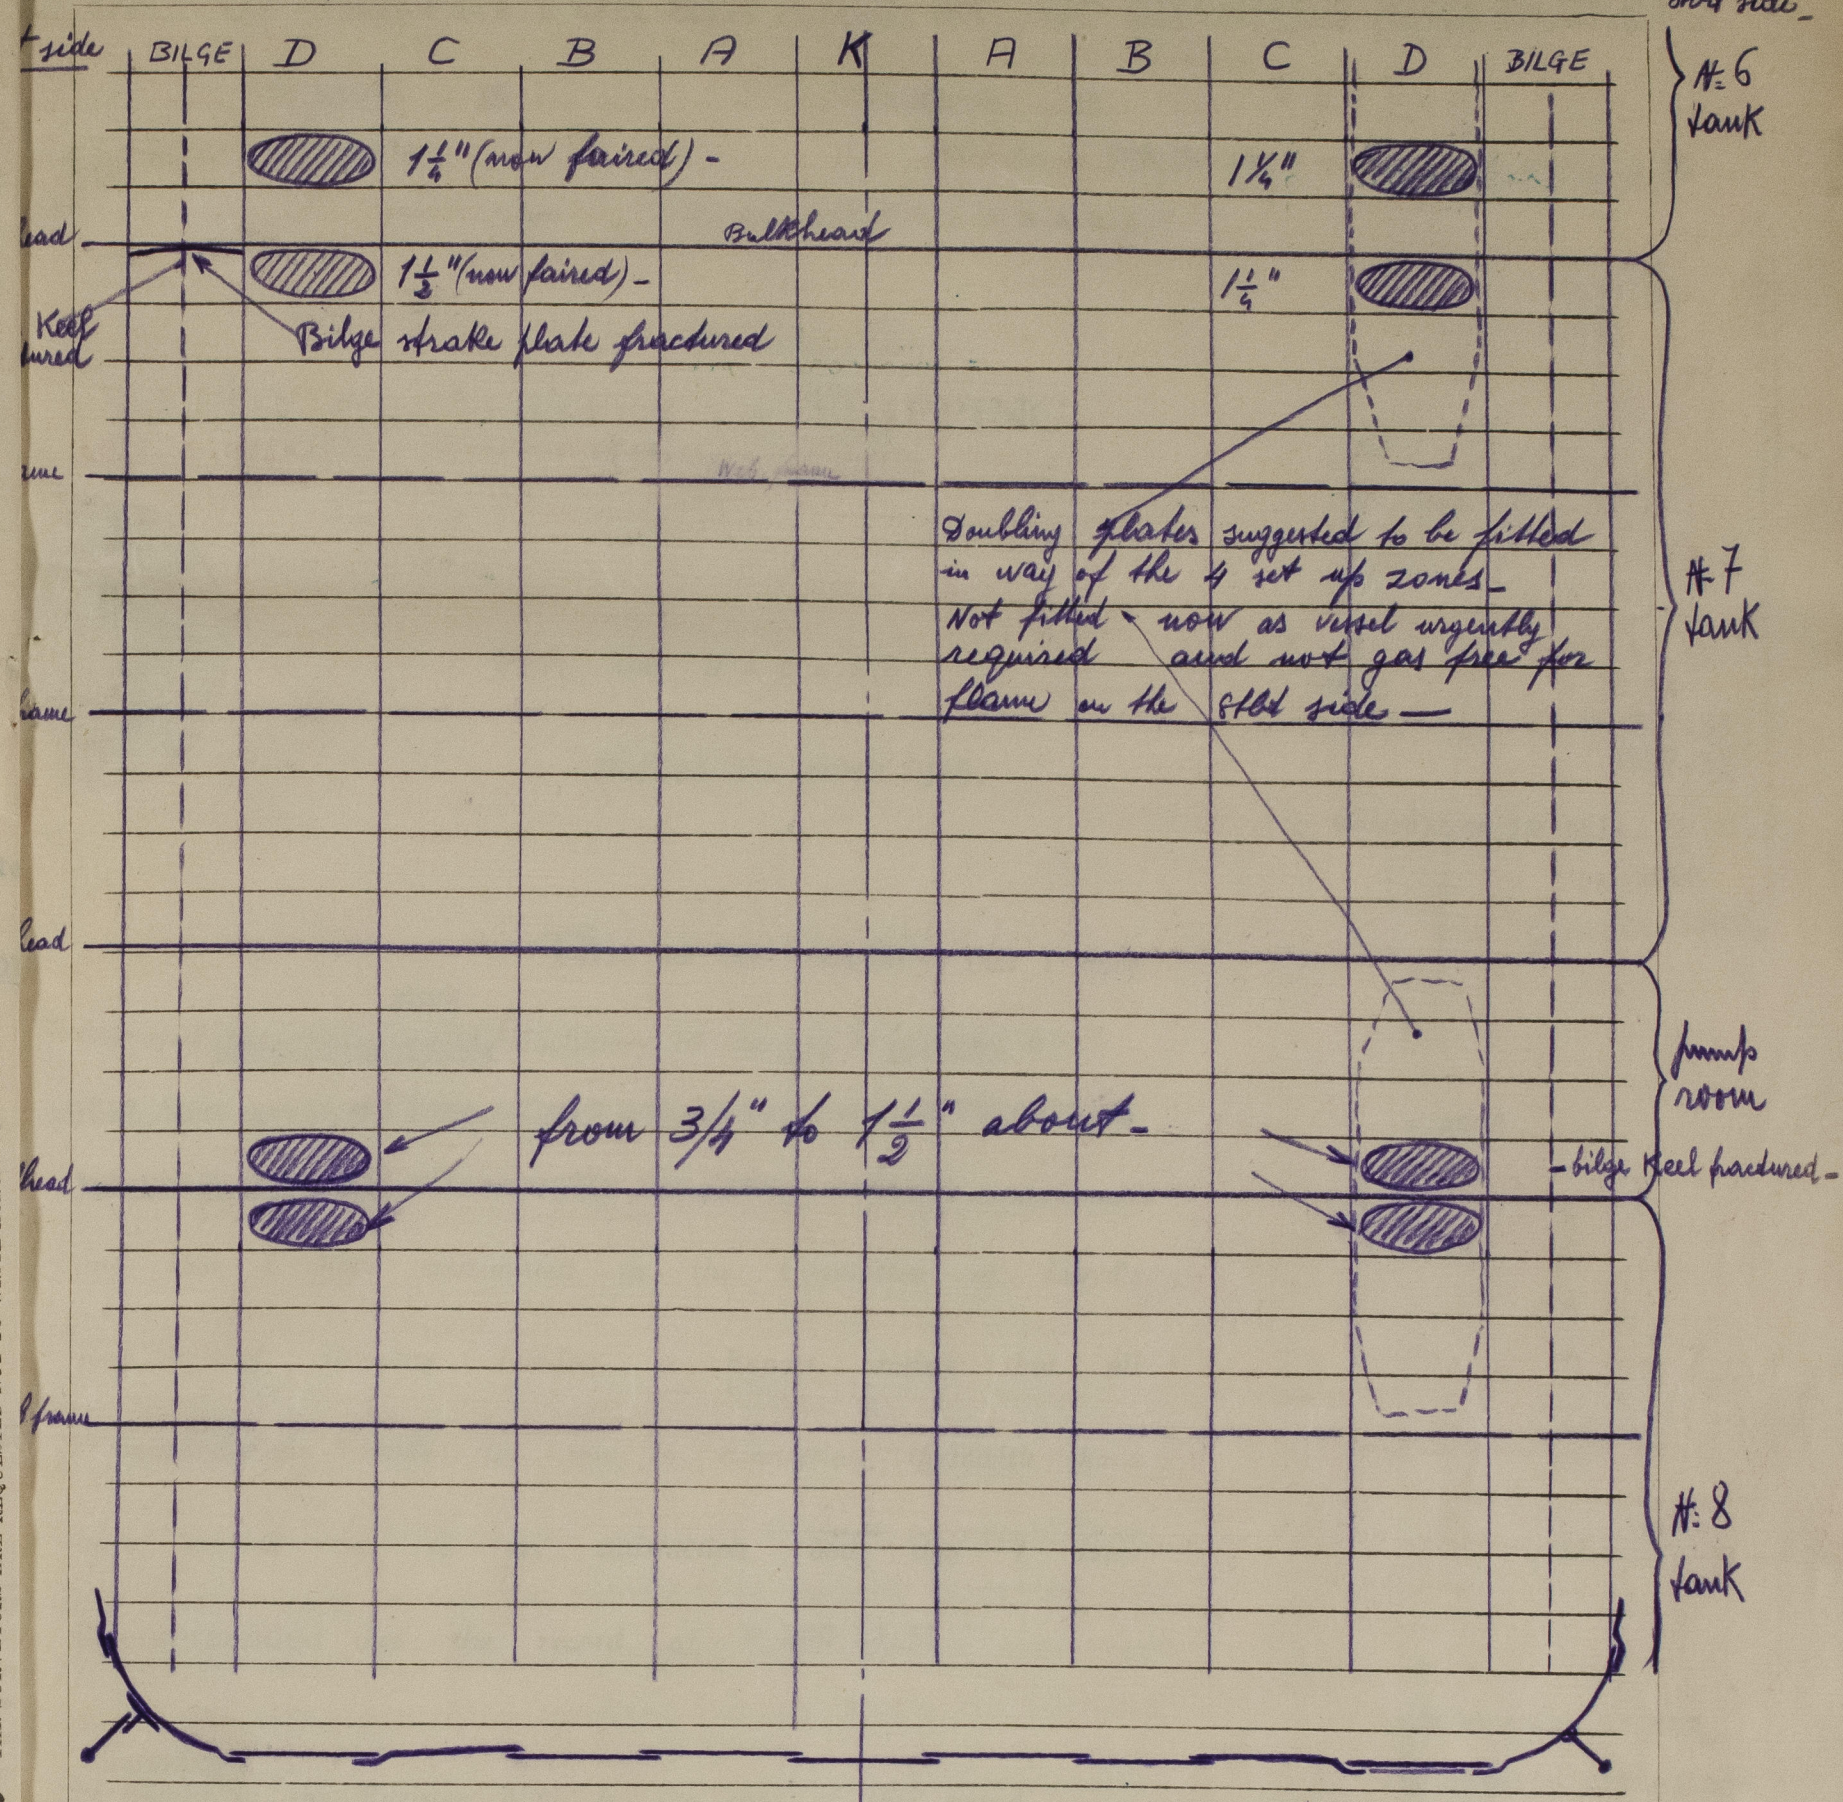
Doubling flanges suggested to be fitted
in way of the 4 set up zones -
Not fitted - now as vessel urgently
required and not gas free for
flame on the old side -

from $\frac{3}{4}$ " to $1\frac{1}{2}$ " about -

- bilge keel fractured -

It has been suggested to fit doubling plates to the D strakes in way of the four zones where the shell plating is set up and the plates presents marks of fatigue, previous the fairing of the damaged plates, but being the vessel urgently required and the stbd side tanks not gasfreed for flame this proposal has not been carried out. It has been recommended to have the bottom plating, in way of N° 6, 7 tanks, after pump room, and N° 8 tanks port and starbd specially examined and dealt with at the next special survey.
