REPORT OF SURVEY FOR REPAIRS, &c., OF ENGINES AND BOILERS

Reg. Book. 27139 on the Machinery of the Wood, Iron or Steel Sc Steamer "CITY OF CARLISLE"

Steel S. Steamer "City of Carlisle"

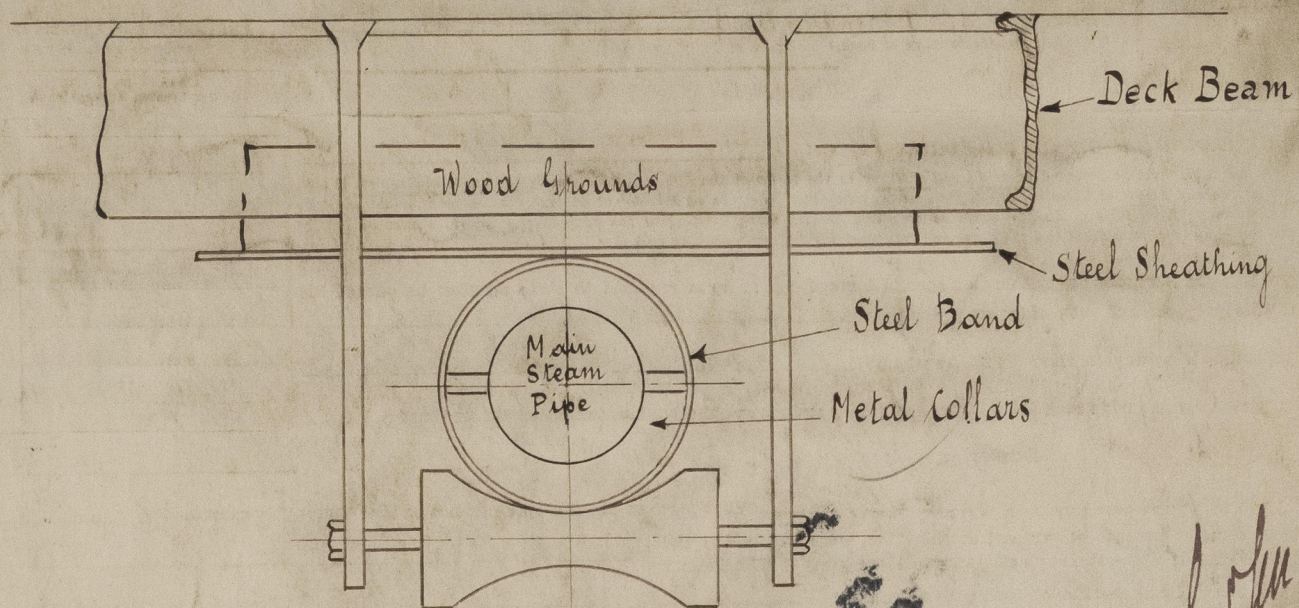
- Meat Room -

NOW DONE The refrigerator insulation in the Engine Room below the domestic meat room was examined and found to be smouldering in way of the main steam pipe. The steel plates supporting the insulation were removed in way of the fire and all burning insulation and wood grounds removed.

It was noted that the metal collar on the main steam pipe, in way of one of the pipe hangers, appeared to have been in contact with the steel plating which

supports the meat room insulation. Care was taken in assembling the temporary insulation to leave an air gap between the collar and the steel plating.

Fire damage in engine room is done to  
refrigerated chamber insulation.  
Steam pipes fixed clear of insulation
