Ship's Name SS/MS "LUCERNA"

Port FALMOUTH.

Rpt. No. 14307.

DOCKING AND DAMAGE.

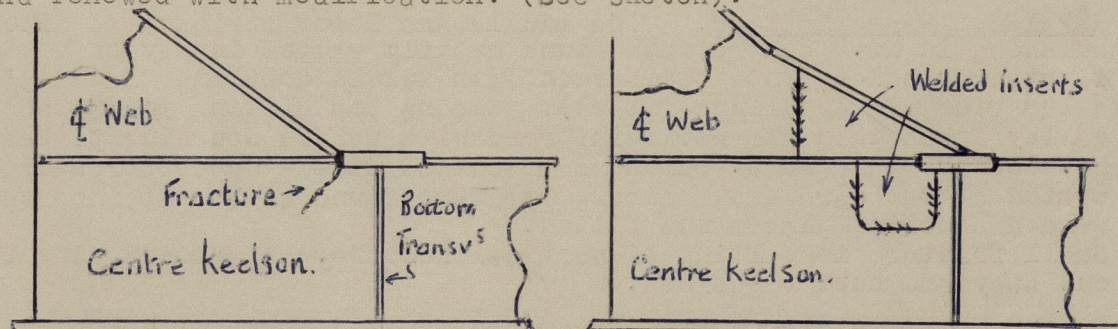
The centre keelson found fractured at connection of ford. bulkhead centreline web in No.4 tank. Keelson cropped and part renewed with a welded insert and toe of web frame plating and face bar cropped and renewed with modification. (See sketch).
