Lloyd's Register of Shipping.

Ship's Name "EMPIRE GAT"

Official No. 168674.

Memorandum of alterations reported since ship was surveyed for assignment of Load Lines in

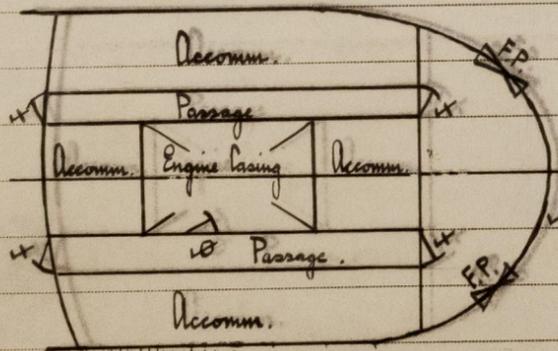
The steel deckhouse aft has been altered and now extends from side to side of the vessel, the deckhouse is efficiently constructed and protects the engine casing, access to the engine room is arranged as shown in the sketch.

✗ Openings in fore and after end/bulkheads of deckhouse, each 4'-9" x 24", sill 18" closed by means of strong hinged wood doors, capable of being operated from both sides. ✓

✗ Opening in casing side, 5'-6" x 24", sill 6", closed by means of a hinged steel gastight door, capable of being operated from both sides. ✓

71.5 ft. long and has two freeing ports each side, one at 14'-6" x 6" and one at 13'-6" x 6", area 14 sq. ft. each side. A small well has now been formed at the after end of the after deckhouse, this well is 9'-2" long and has one freeing port, each side, 1'-10" x 9", 6" above deck edge, no rails, bars or shutters fitted, area 1.37 sq. ft. each side. (See sketch on previous page).
