REPORT OF SURVEY FOR REPAIRS, &c.

Reg. Book 7334 on the M.V. "PERICLES" (No. of Visits Seven)

PAIRS, OR EXAMINATION AS PER RULE FOR DOCKING DAMAGE and REPAIRS.

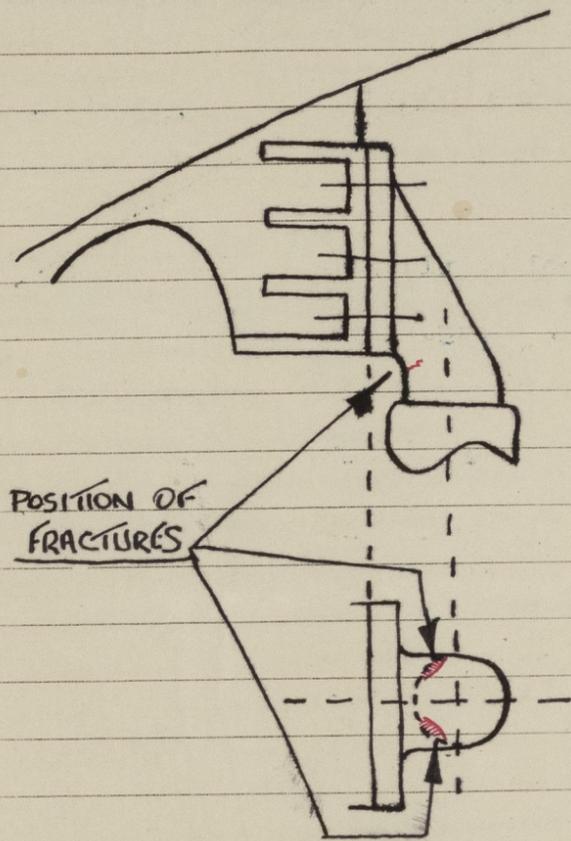
DAMAGE 'C' to pintle shaft of rudder.

Rudder pintle shaft fractured port and starb' at the neck of the shaft immediately below the upper palm coupling (see sketch).

Pintle shaft removed with rudder and fractures to shaft eliminated by cutting subsequently magno-flux tested at a depth of removal of material of eleven m/m. for both p & s fractures.

The shaft preheated and welded and finally dressed smooth, checked for distortion and found satisfactory.

It was necessary to machine back the upper shaft liner by some two inches prior to welding.

The above constitutes a satisfactory repair but it is recommended that same be re-examined within six months.

This can be done afloat.
