REPORT OF SHIP SURVEYS AND REPAIRS

No. in R.B. 82431 on the ~~STEEL~~ Steel M.S. "TAKEI MARU"
Built at Aioi By Whom Harima Zosenso Tons gross 11,868
Owners Kyoiei Tankers K.K. Owners' address (If not already in R.B.)
Managers Port of Registry Kobe
Surveyed Afloat or in Drydock Both Name of Dock Ishikawajima-Harima Heavy Ind. Ltd. Date of last examn. in Drydock 7/6/61

EXAMINATION AND REPAIRS AS PER RULE FOR Damage, Docking and Completion of Periodical Special Survey 'B' due 4,60 See Kobe Report No. 7945 also Classn Letter 14th Oct., 1960.

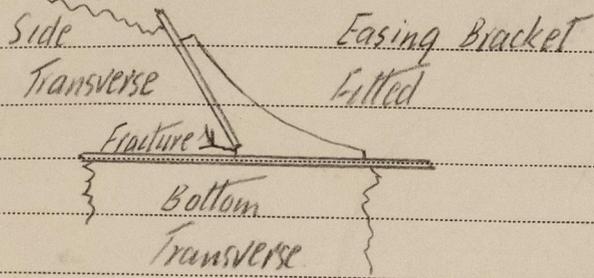
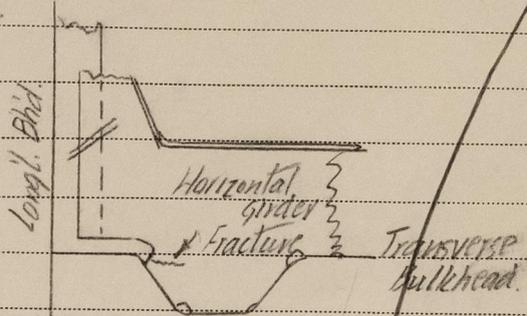
SKETCH A

No.2 Starboard Fr. 166 side shell transverse connection to bottom transverse. Fracture at toe of web, Fracture veed out and welded. Radiused bracket fitted and face plate further sniped at toe (see sketch A).

Cargo Oil Tank No.4 Starboard Fr. 130 side shell transverse connection to bottom transverse also fr. 134 side shell transverse and side transverse to longl. bulkhead connection to bottom transverse. Fracture at toe of web. Fracture veed out and welded and radiused bracket fitted and face plate further sniped at toe (see sketch A). Bhd 118 No.2 horizontal girder, Fr. end connection to longl. bhd. Fracture at toe of bracket (see sketch C).

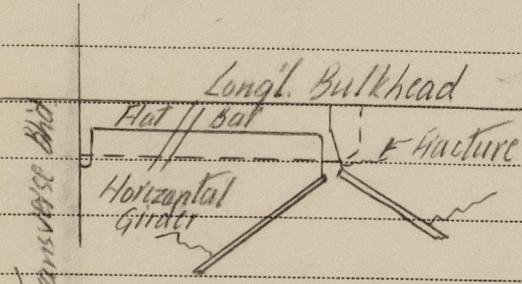
SKETCH B

Bhd 158 Nos. 1 & 2 horizontal girders from bottom. Fracture at scallop (see sketch B). Girder cropped and insert piece fitted. Scattered pitted areas at bottom shell plating frs. 158 to 162. Scaled and welded.

No.2 Port Bhd 158 Nos. 1 & 2 horizontal girder from top, also bhd 174 No.2 horizontal girder. Fracture at scallop (see sketch B). Girder cropped and insert piece fitted and welded to girder and bhd.

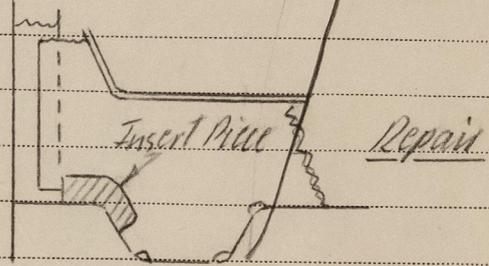
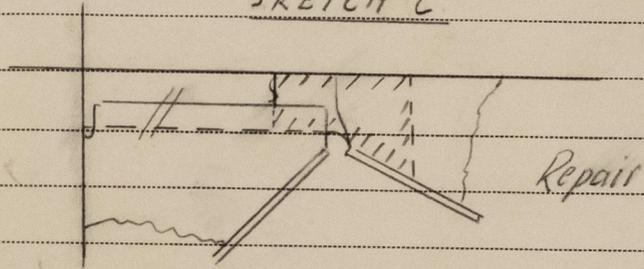
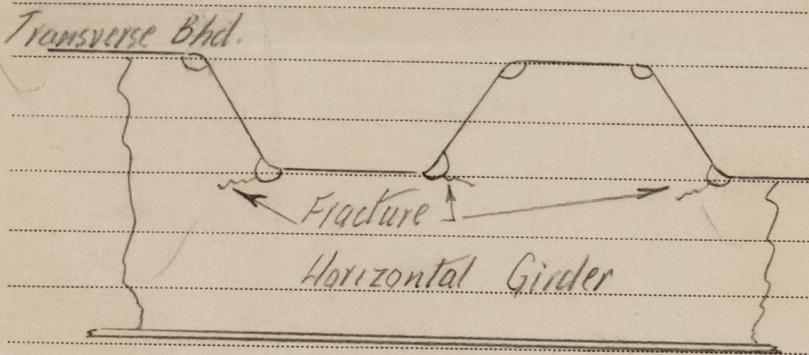
SKETCH C

Bhd 102 Nos. 1 & 2 horizontal girders. End connection to longl. bhd. Fracture at toe of bracket (see sketch C). Flat bar connection to bulkhead cropped and part renewed.
 Bkds. 86 and 102 Nos. 1, 2 & 3 horizontal girders. Fracture at scallop (see sketch D) girder cropped and insert piece fitted and welded to girder and bulkhead. Total 10 insert pieces fitted. Scattered pitted areas of bottom shell between frs. 86 to 90 scaled and welded.
 No. 6 Starboard Frs. 90, 94, 98 side shell transverse connection to bottom transverse also fr. 94 side transverse to longl. bulkhead connection to bottom transverse. Fracture at toe of web. Fracture veed out and welded. Radiused bracket fitted and face plate further sniped at toe (see sketch A).
 Bhd 102 Nos. 1 & 2 horizontal girder. End connection to longl. bhd. Fracture at toe of bracket (see sketch C). Flat bar connection to bulkhead cropped and part renewed.

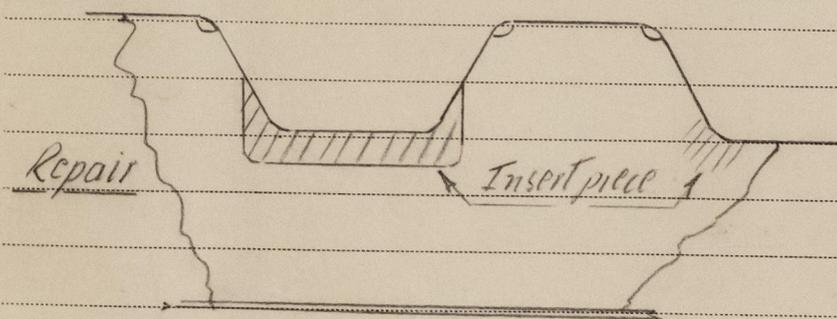
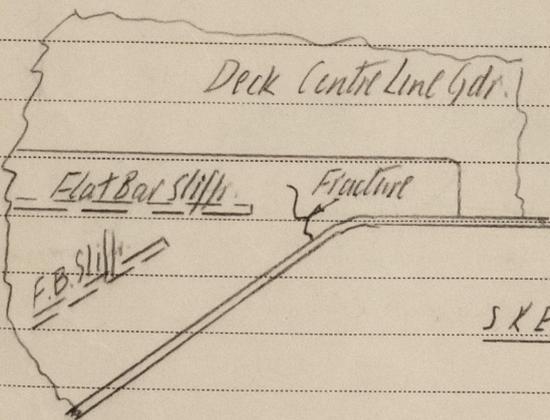
SKETCH D

REMARKS, REPAIRS, Etc. (Contd.) Cargo Oil Tank No. 4 Starboard (Continued)
 Flat bar connection to bulkhead cropped and part renewed. Fracture veed out and welded. Bhd 142 Nos. 1, 2 & 3 horizontal girder from top. Fracture at scallop (see sketch D). Girder cropped and insert piece fitted and welded to girder and bulkhead. Total 6 insert pieces fitted.
 Cargo Oil Tanks No. 4 Port Frs. 122, 130, 134 side shell transverse connection to bottom transverse. Fracture at toe of web. Fracture veed out and welded. Radiused bracket fitted and face plate further sniped at toe (see sketch E). Centre girder cropped and part renewed also flat bar stiffener. Ends 102 and 118. End bracket and centre line web connections to bottom centre girder. Fracture at toe of bracket and web. Fracture veed out and welded. Radiused easing crackets fitted, 1000 x 1000 x 15mm. Fr. 110 bottom transverse end bracket connection to longl. bulkhead F. & S. Fracture at toe of bracket to bulkhead. Doubling piece fitted under toe of bracket and welded thereto and to bulkhead. End 118 No. 2 horizontal girder end connection to longl. bulkhead. Fracture on bulkhead at toe of bracket. Fracture veed out and welded and doubling piece fitted and welded under toe of bracket to bulkhead.

Bkds. 86 and 102 Nos. 1, 2 & 3 horizontal girders. Fracture at scallop (see sketch D) girder cropped and insert piece fitted and welded to girder and bulkhead. Total 11 insert pieces fitted.
 A number of minor repairs also effected at this time.

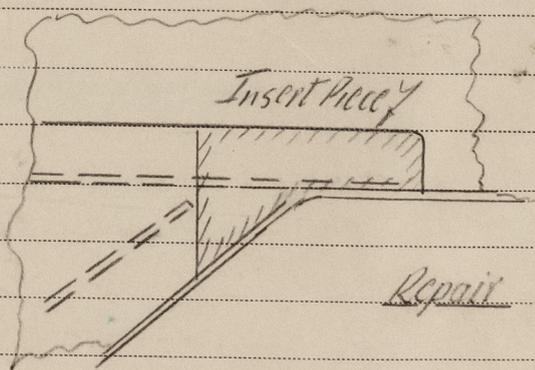
SKETCH E

No. 5 Centre Bhd 102 End bracket connection of deck centre line girder. Fractured at centre girder (see sketch E). Centre girder cropped and part renewed also flat bar stiffener. Ends 102 and 118. End bracket and centre line web connections to bottom centre girder. Fracture at toe of bracket and web. Fracture veed out and welded. Radiused easing crackets fitted, 1000 x 1000 x 15mm. Fr. 110 bottom transverse end bracket connection to longl. bulkhead F. & S. Fracture at toe of bracket to bulkhead. Doubling piece fitted under toe of bracket and welded thereto and to bulkhead. End 118 No. 2 horizontal girder end connection to longl. bulkhead. Fracture on bulkhead at toe of bracket. Fracture veed out and welded and doubling piece fitted and welded under toe of bracket to bulkhead.
 No. 6 Port Fr. 90 side shell transverse connection to bottom transverse also fr. 94 side shell transverse connection to bottom transverse and side transverse to longl. bulkhead connection to bottom transverse. Fracture at toe of web. Fracture veed out and welded, radiused bracket fitted and face plate further sniped at toe (see sketch A).
