Ship's Name SS/MS "WINCHESTER QUEEN" Gross tons 7.176
 LR 516.284
 Is there a rpt. 8? No Port DAKAR Rpt. No. DK 253
 No. of visits First date Last date
 Interim Cert. issued & copy herewith? Yes Damage rpt. issued & copy herewith? No Last rpt. (H.Q. only)
 Date of completing rpt. Surveyed at, if different from Port above
 Is a rpt. 9A attached? Yes MN Nature of survey Damage and Wear and Tear Repairs
 Survey fees Damage fee Expenses
 (see Rpt. 9A) S.A. fee

Ship's Name SS/MS "WINCHESTER QUEEN"
LR 516.284

Rpt. No. DK 253

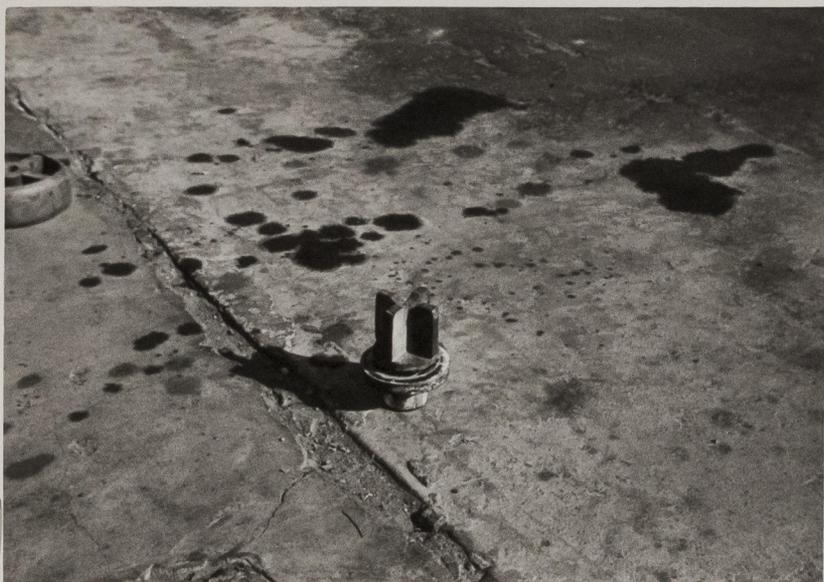
Photo N° I

Several valves clappers fractured (photograph N° I) and valve seats slack.

All main and auxiliary feed checks *now overhauled as necessary*

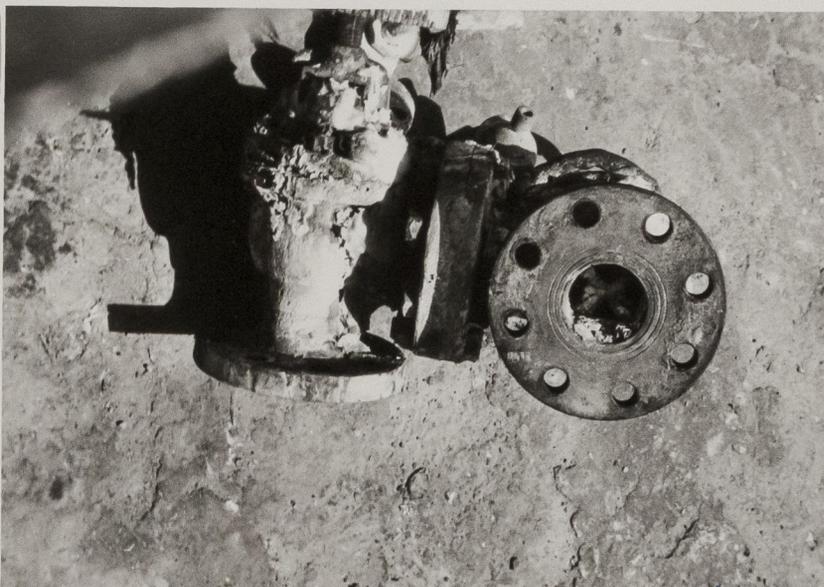
Photo N° Ibis

Boilers (Port, Centre and Stbd.) Main and auxiliary feed checks either jammed by sediment (see photograph N° Ibis) or heavily leaking.

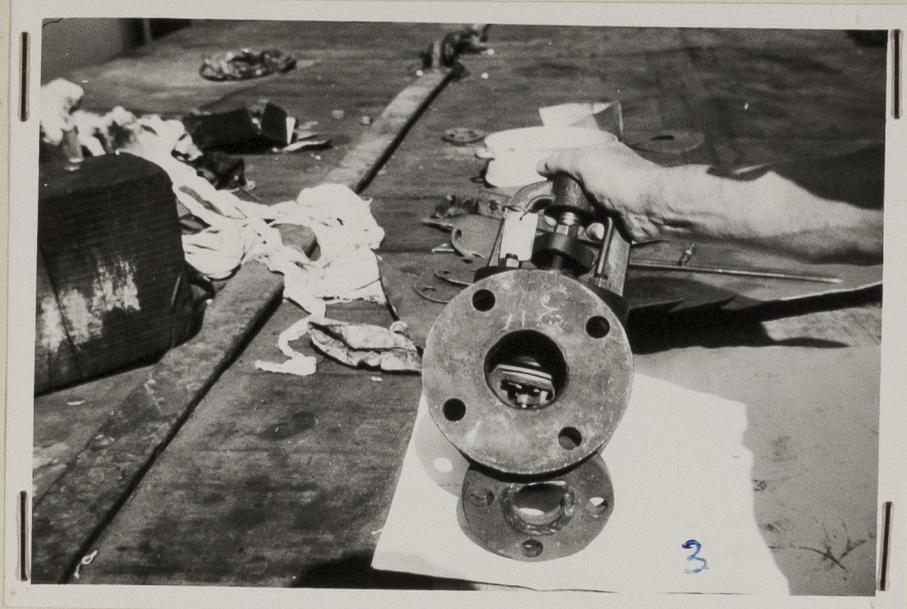
Photo N° 3

Found holed at several places. Now partly renewed.
Boilers water recirculating valves from blowdown lines to general service pump suction chest, were found heavily leaking (see photograph N° 3) and the blowdown valves on boilers being also leaking, it is supposed that a quantity of boiler-water has been discharged overboard by the G.S. Pump during the voyage completed.

Both recirculating valves have been renewed.
