Report of Survey for Repairs, &c., of Engines and Boilers.

Report No. 243 March 1943 When handed in at Local Office 25.3.43 Port of MARSEILLES

on the Machinery of the Wood, Iron or Steel S/S "CONDE"

S/S "CONDE",

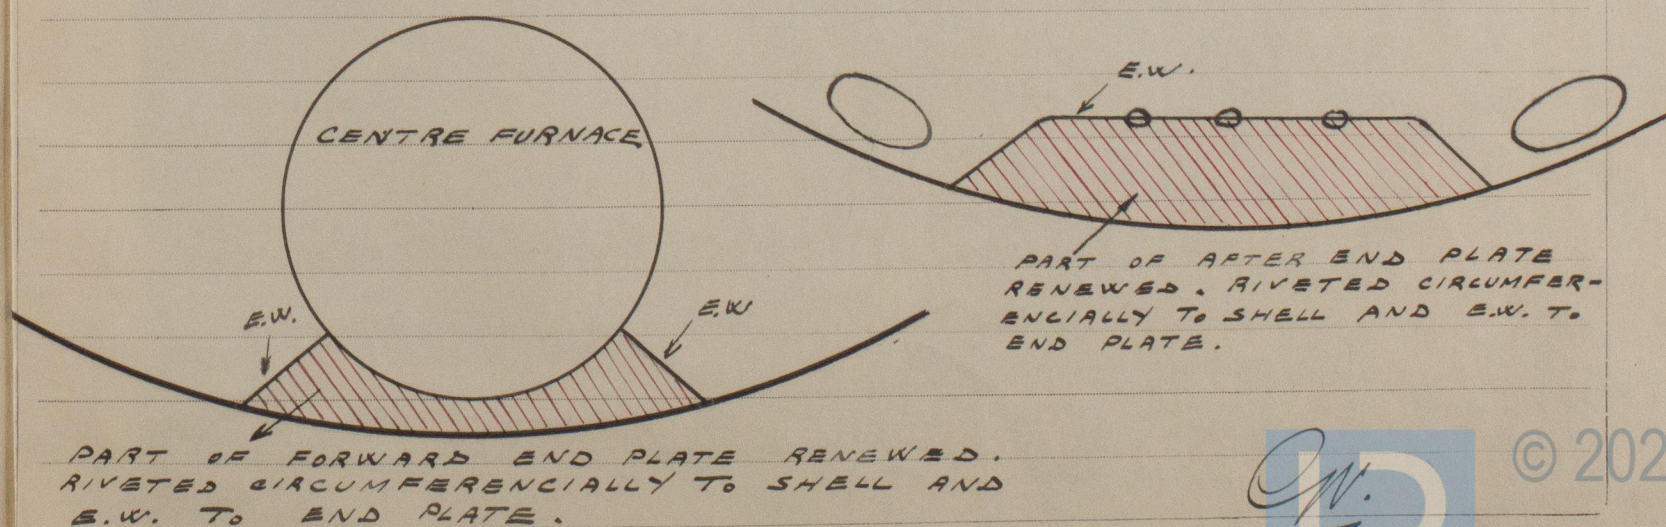
REPAIR TO FORWARD END
PLATES OF THE THREE
MAIN BOILERS.

Found the front end plate flanges below the centre furnace of the three main boilers badly grooved. The front end plates below the centre furnace of the three main boilers have now been renewed as per sketch.

The three main boilers were tested to 240 lbs./sq. hyd. pres. on completion of the repairs mentioned above and were found tight.
