0129-0043

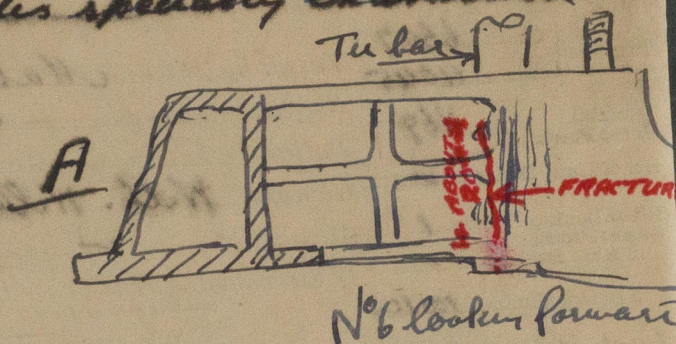
Port bedplate N°6 bearing bridge fractured on  
after side of box section housing tie bar as  
per sketch "A" and N°7 bearing bridge fractured  
to a greater extent as per sketch "B"  
fractures indicated in red.

Port bedplate N°7 bridge reinforced by fitting  
7/8" plates on forward and after sides of bridge the plates  
extending the full width of crank pits with toes bearing  
on bare flange, these plates secured by fitted bolts in  
way of ribbed I section and by expanded dowels  
and screwed stays where crank web clearance precluded  
use of bolts, all bolts and dowels shot welded in place.  
See blueprints herewith.

Time and existing conditions did not permit of repairs to  
N°6 bridge which remains to be repaired before the vessel  
proceeds on her outward voyage.  
The holding down bolts and bedplate chocks also  
remain to be overhauled.
