REPORT OF SURVEY FOR REPAIRS, &c.

23rd Dec. 1952 When handed in at Local Office 24th Dec. 1952. Port of Hong Kong.
held at Keelung Date, First Survey 13th Dec. Last Survey 17th Dec., 1952.
Wood, Iron or Steel S.S. "SAN ROBERTO" (No. of Visits 5)

AMINATION AS PER RULE, FOR STATED HEAVY WEATHER DAMAGE & TEMPORARY REPAIRS.

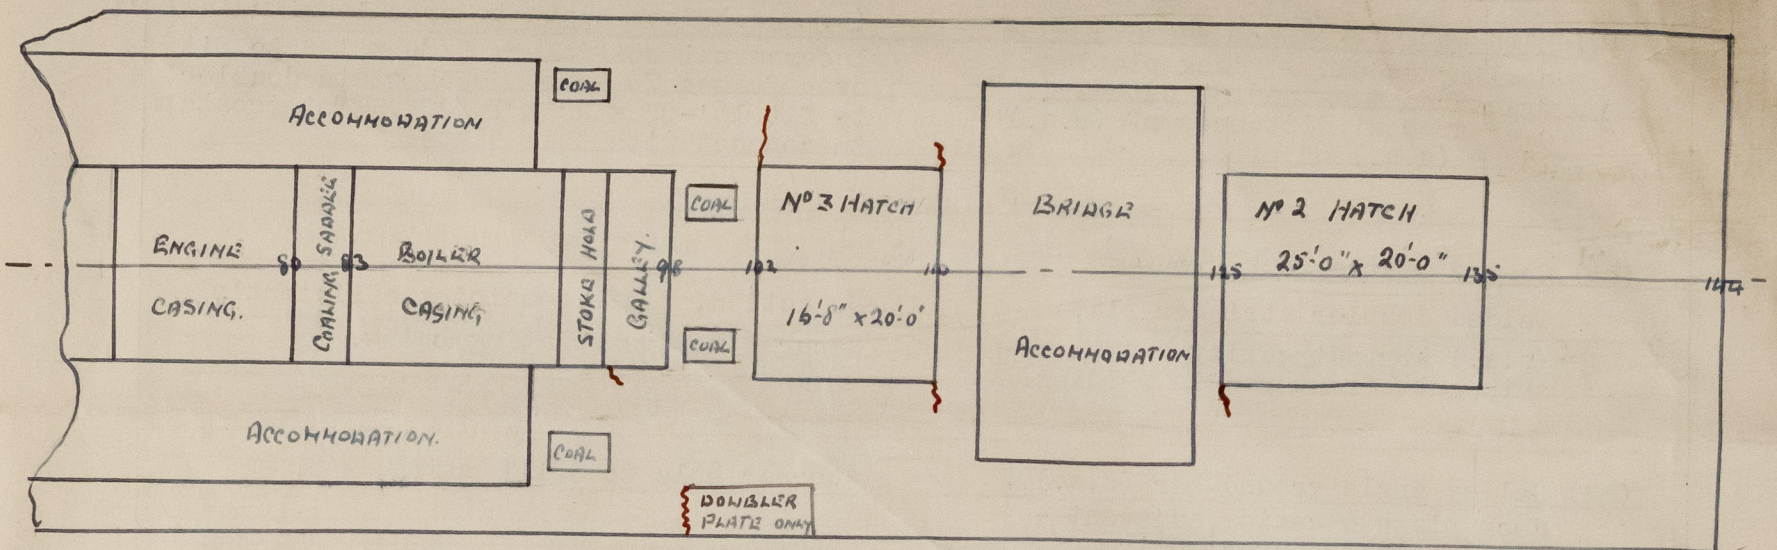
CENTRE CASTLE DECK PLAN (NOT TO SCALE)

FOUND TEMPORARY REPAIRS RECOMMENDED
ld (p.s.) shell plate J strake No.2 Additional 5/8" stringer plates to fit 2'-0"
ter bulkhead fractured in way of above & below fracture from after bulkhead
angle between frames Nos. 143 & 144 to fr. No. 146 connected by E.W. to frames &
to bulkhead by welded brackets, all to be

SHOWING POSITION OF FRACTURES (RED)

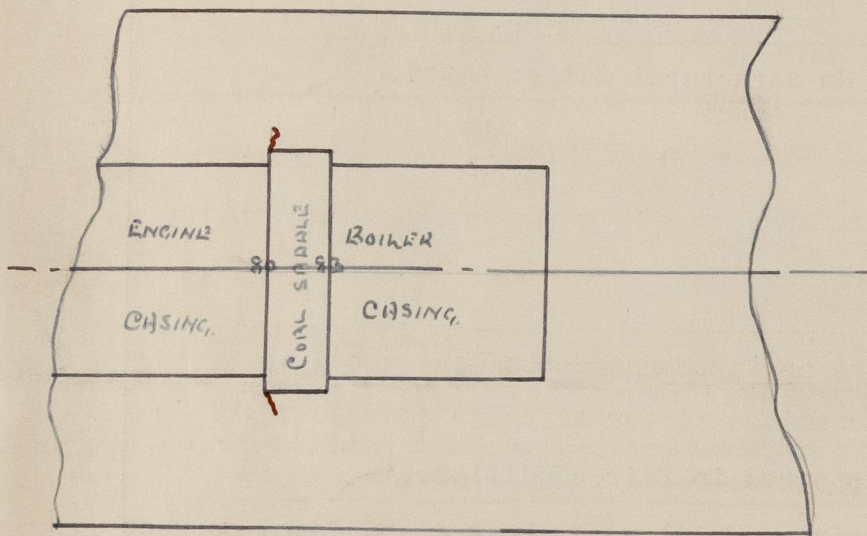
MAIN DECK PLAN (IN WAY OF COAL SADDLE)

SHOWING POSITION OF FRACTURES (RED)
