Laboratory

June 2, 1933

SUBJECT: Supplement to Report Entitled, Physical Characteristics of Plates Removed from the S.S. Charles Pratt, J.O. 1808-S, Dated May 23, 1933.
Lab. Test #376.

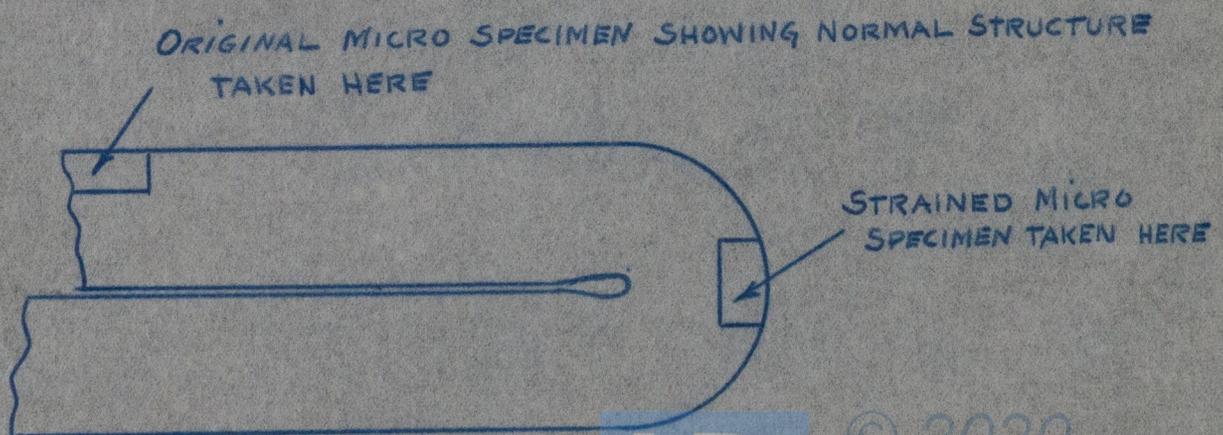
The bend specimen representing Deck Stringer Frame 363 (which was bent 180° around a pin of diameter three times the plate thickness) was further bent until it was 180° flat on its self, as per the following sketch.

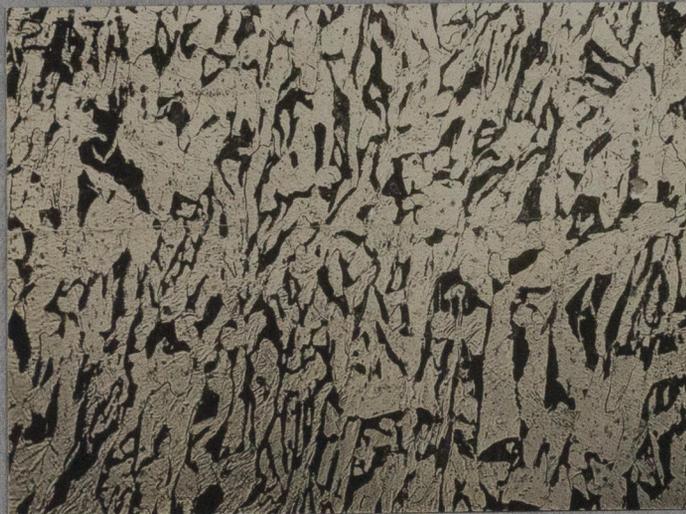
The Photomicrograph below, taken at a magnification of 100X, shows the structure of the Deck Stringer Frame 363 after it had been strained beyond its elastic limit and can be compared to the Photomicrograph of the Deck Stringer Frame 363 in its unstrained condition as shown on page 11 of the report of May 23rd.

You will note that the white areas, or the ferrite, contain numerous small lines which are termed strain or slip lines caused by being subjected to distortion. The pearlite or dark areas do not show these slip lines for the ferrite is harder than the pearlite and hence less pliable.

Both the ferrite and the pearlite distort however under strain and you will note that in the above micrograph they have been elongated due to the severe bending and may be compared to the micrograph

on page 11 of the report of May 23rd where they are both normal and do not lie in any particular direction.

The distorted structure of the pearlite as shown in Photomicrographs N-21-S and Longitudinal #19 on pages 10 and 11 of the original report is termed banded structure, cause of which is not definitely known but the consensus of opinion is that it caused by the elongation in rolling of a peculiar crystallization present in the original ingot. This condition should not be confused with the elongated structure of the above micrograph.
