# Report of Survey for Repairs, &c., of Engines and Boilers.

Date of writing Report 18<sup>th</sup> Nov. 1927 When handed in at Local Office 18<sup>th</sup> Nov. 1927 Port of ANTWERP

No. in Reg. Book. 26978 Survey held at GHEENT Date, First Survey 9<sup>th</sup> Nov. Last Survey 10<sup>th</sup> Nov. 1927 (No. of Visits 3)

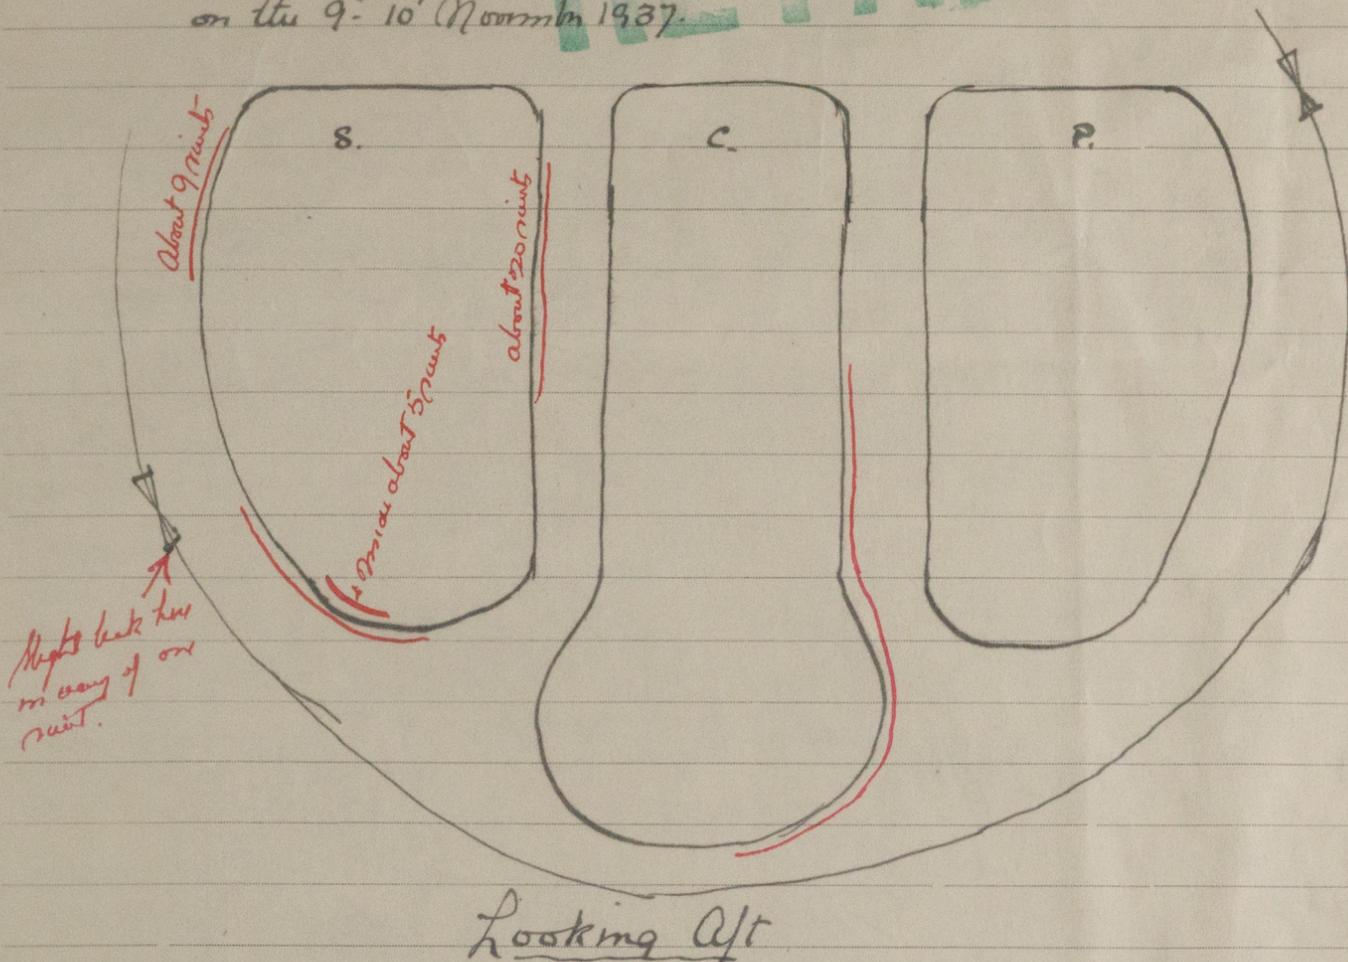
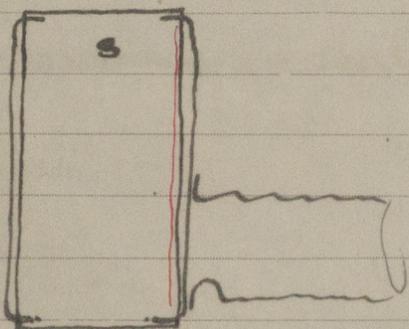
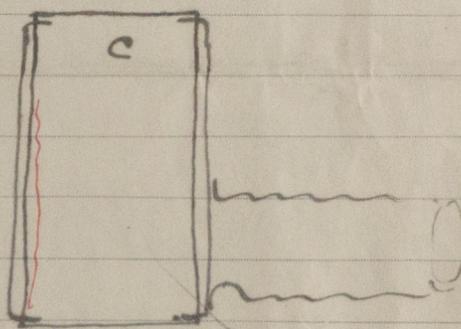
Sketch showing tracks in combination chamber wrapper plate in Starboard Bulk of the 's IRENE MARIA found at Ghent on the 9:10' November 1937.

The wrapper plates of the centre and starboard combustion chambers were found to contain serious cracking between the rivet holes, as shown on the attached sketch and it was recommended that the wrapper plates be removed for examination of the tube and back plate flanges and repairs carried out as found necessary; and that a rivet be removed from the outboard longitudinal butt strap for examination of the

rivet and plate in way.

The machinery of this vessel is eligible, in our opinion, to remain as classed without fresh record of survey subject to the starboard boiler not being used until permanently repaired and the boiler survey completed as above.

It was further recommended that this bulb should not be used until further examined and permanently repaired.
