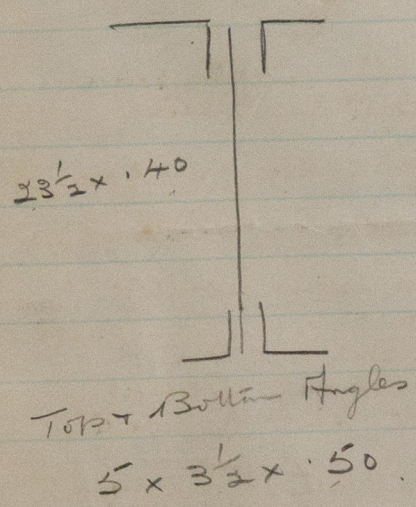
### Rule

$$\text{Rule } \frac{1}{2} = 199\frac{1}{2}$$

This submitted the surveyor he requested  
to inform the owners that the rule  
requirements for the hatchway web  
is a plate  $23\frac{1}{2}'' \times .40$  with double  
angles top and bottom  $5 \times 3\frac{1}{2} \times .50$   
and the web the fitted must be  
equivalent thereto.

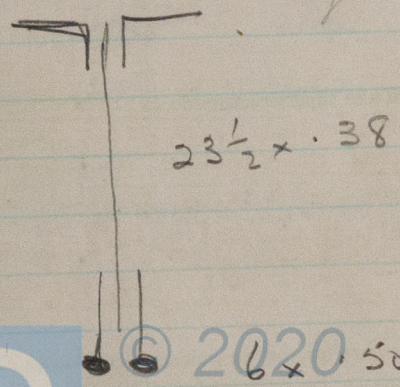
### Proposed

$$5\frac{1}{2} \times 3\frac{1}{2} \times .48 \text{ Tips angles}$$

If it be desired to dispense with  
bottom angles the web would  
require the of the scantlings  
intimated in the Secretary's  
letter of 10<sup>th</sup> inst.
