# Lloyd's Register of Shipping.

In accordance with instructions I left London on the evening of the 19th instant for Antwerp, for the purpose of making an examination of the s.s. "LE PHOQUE", which had sustained extensive damage through being struck by the s.s. "BENNEKOM", while she was lying alongside Quay No. 231, Antwerp, on the 15th December, 1938.

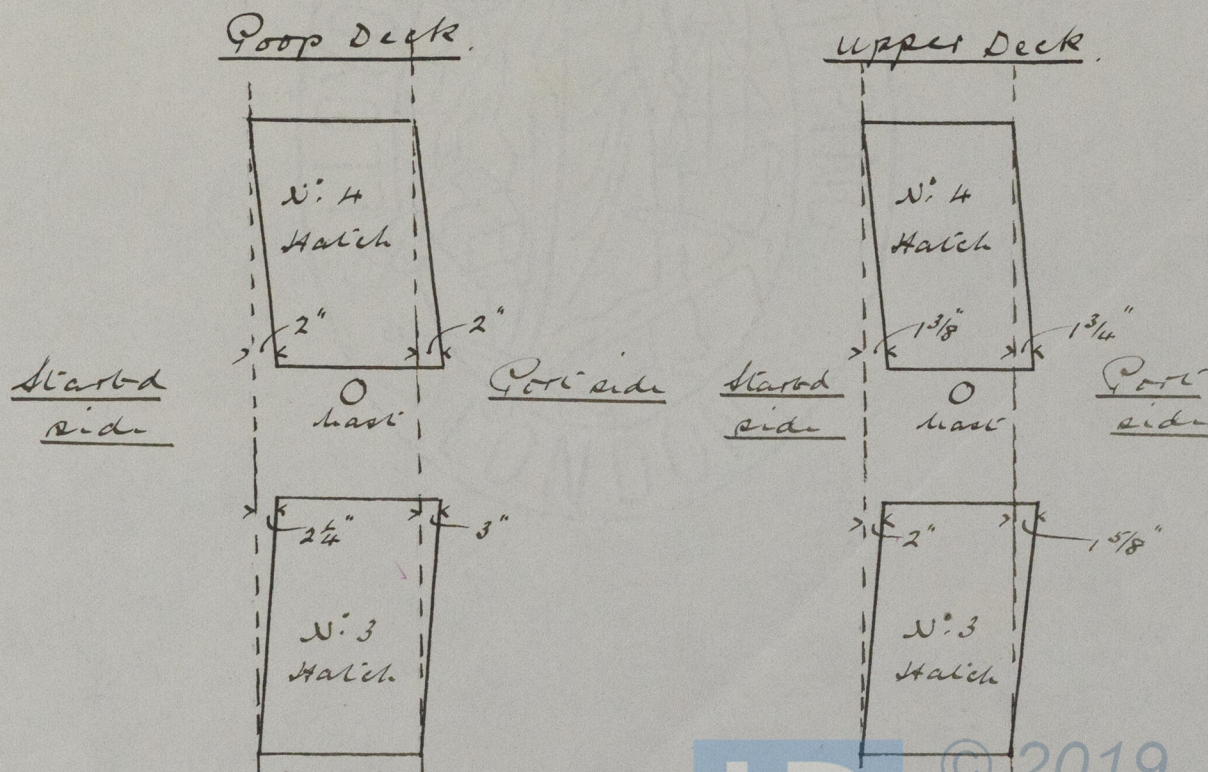
The coamings of Nos. 3 & 4 hatchways were sighted and found to be out of line as shown below :-
