REPORT of SURVEY for REPAIRS, &c.

REPAIRS, OR EXAMINATION AS PER RULE, FOR *Survey of Damage Repairs*

S.S. "HANNAH" CONVENTION TIMBER FREEBOARD.

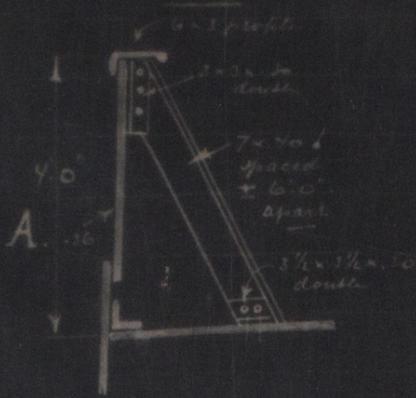
BULWARKS IN FORE- & AFTERWELLS.

Permanent bulwarks are fitted in fore and afterwells stiffened on upper edge by railing profile and supported by stanchions attached to deck by double lugs and to bulwark plate by double lugs as shown in sketch A.

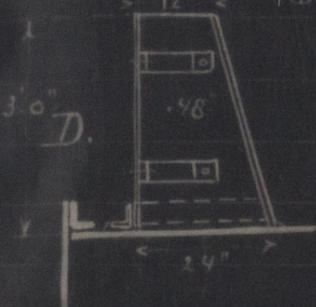
SOCKETS FOR UPRIGHTS ON BRIDGE DECK.

On bridge deck wood uprights are fitted in efficient plate sockets secured by win clips and connected to hidge deck stringer plate by electric welding, see sketch D.
