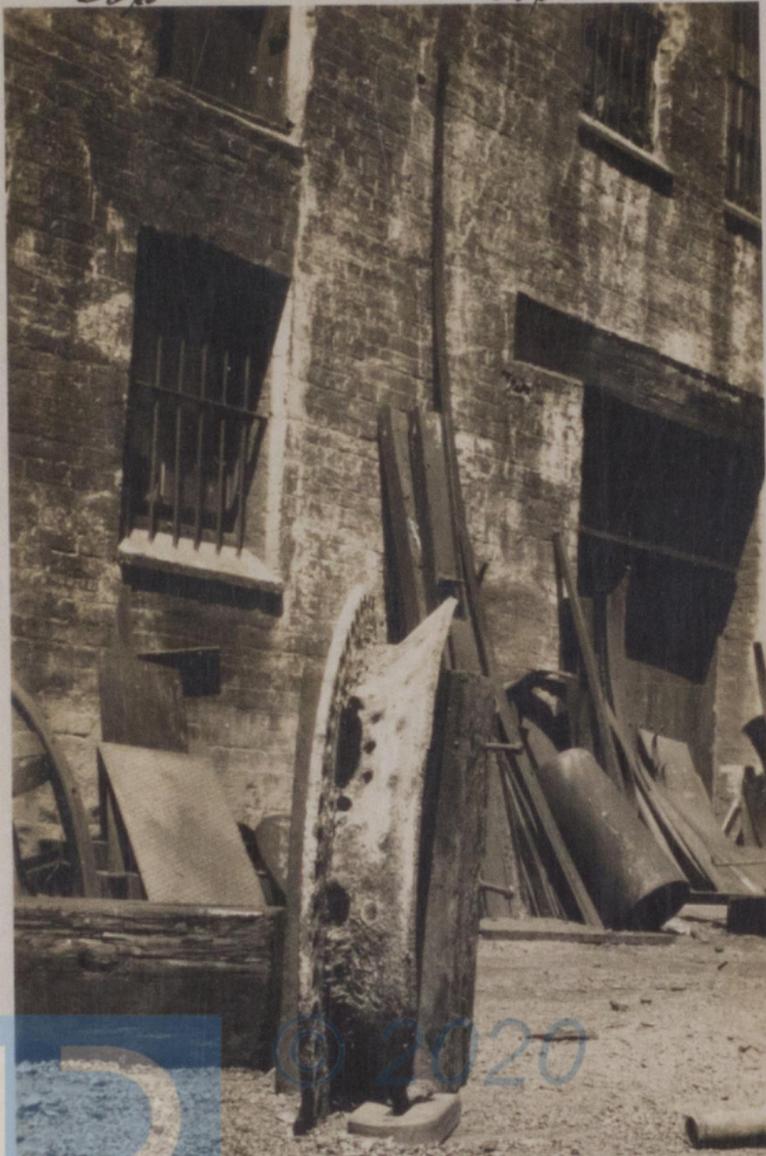
Showing corrugated
part cut out

There was a half bolted
and half riveted patch on
each side of them, also
welding
