No 1 hatch

No 2 hatch

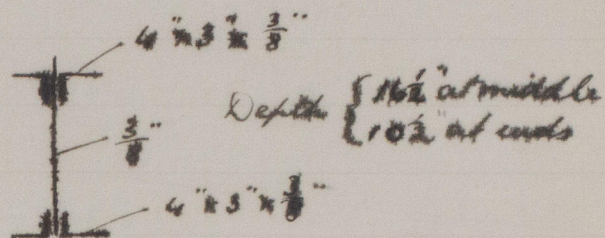
6 Hatch beams

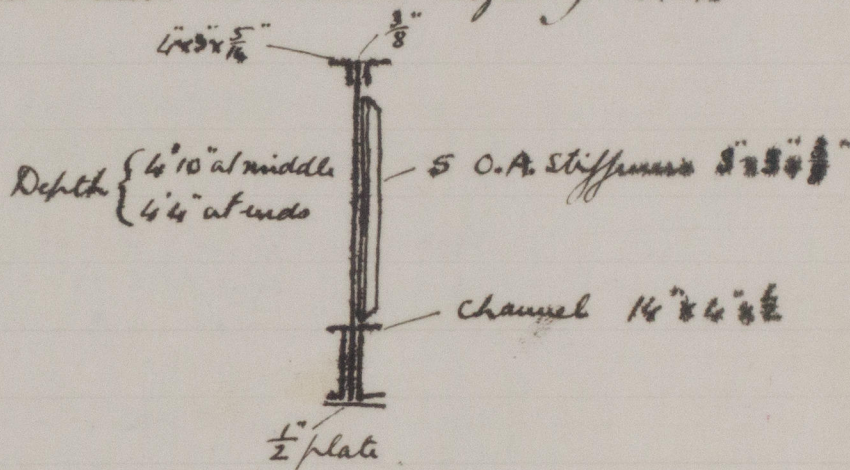
1 Permanent beam at middle length of hatch
