Tanker "M A R K A Y"

Dimensions 503 x 68 x 37

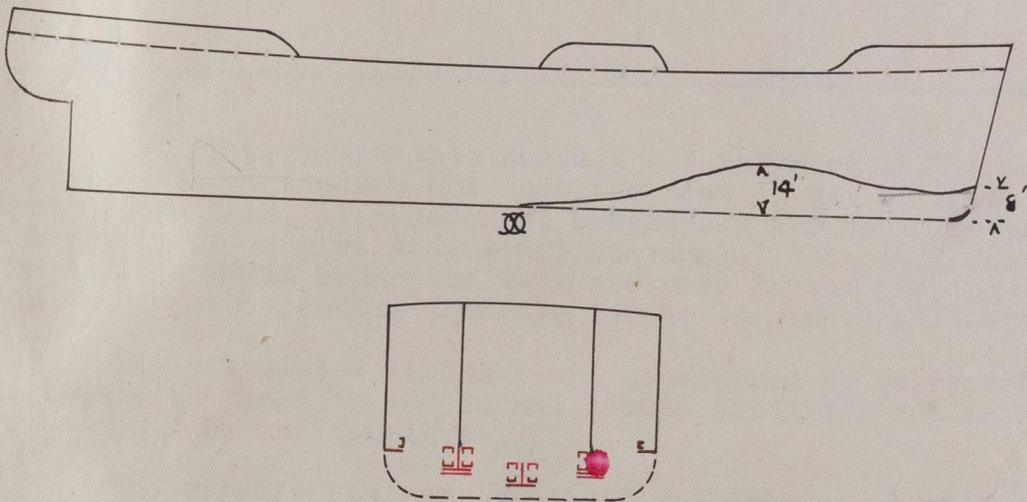
On examination at Swansea it was found that the whole lower portion of the bottom forward of midships had been entirely ripped off.

The question of effecting temporary repairs to enable the vessel to proceed to the U.S.A. was discussed in this office by the Owners and Dr. Montgomerie when it was decided that repairs to the bottom as indicated in red in the sketch would be satisfactory for this purpose.

The bottom of the fore peak tank and of the deep tank forward were plated in, as was also the bottom of No.4 tank starboard.

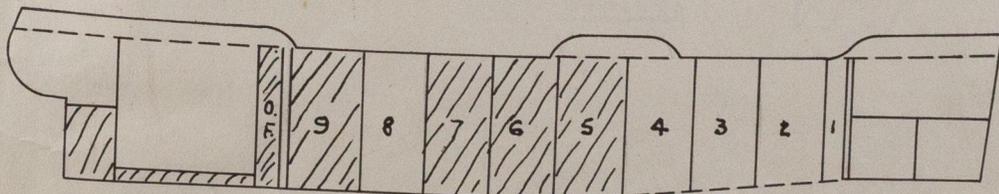
For the voyage the vessel will be loaded as shown below, the estimated draughts being 18' forward and 22' aft.

<u>Hogging.</u>	<u>Sagging.</u>
<u>Normal vessel, fully loaded.</u>	<u>Bottom</u>	:: - 2.8 ::	+ 8.0
<u>Vessel as repaired, loaded as proposed.</u>	<u>Deck.</u>	:: + 2.6 ::	- 7.5
		:: ::	
Aft end of No.4 tank	<u>Bottom</u>	:: - 4.0 ::	+ 3.0
Fore " " "		:: - 4.1 ::	+ 4.4
Middle of No.3 tank		:: - 4.0 ::	+ 4.8
		:: ::	
		:: ::

The calculated stresses are considered to be reasonable in comparison with those in the normal loaded condition and such as could be accepted by the Committee.

It is proposed that Nos.1,2 & 4 tanks be left open at the deck to the atmosphere but that the deck in way of No.3 tank be sealed so that, if necessary, compressed air could be used in this compartment to give additional buoyancy. This will result structurally in a small reduction in the stress in the hogging condition and a corresponding increase in the sagging condition.
